**HARSIA**  
Hellenic Air & Rail  
safety Investigation Authority

Rail Accident Report

Head-on collision between a passenger train and a freight train  
in Tempi, 28 February 2023

RL01-2025, 27 February 2025

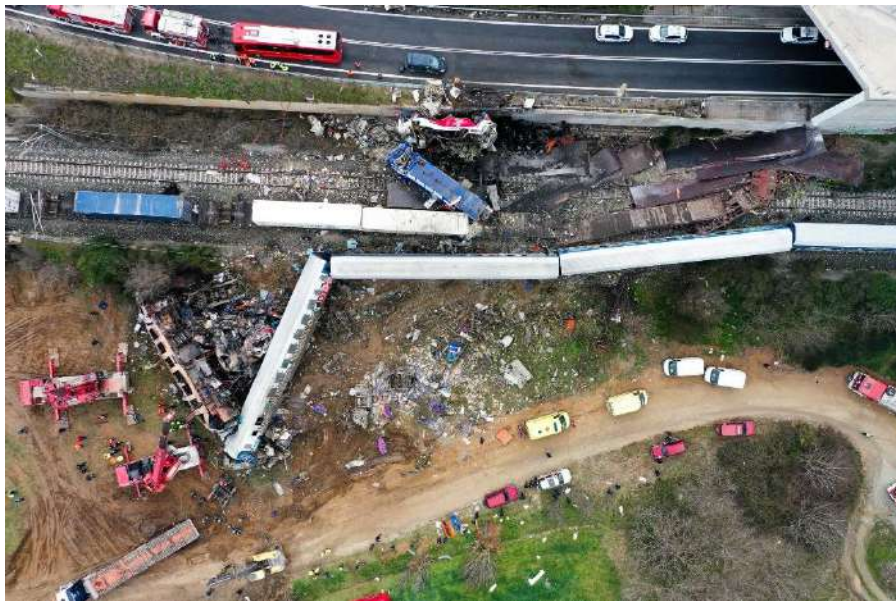
Figure 10. The end position of the 3 locomotives and some of the passengers coaches and freight wagons (<http://www.intime.gr/>).

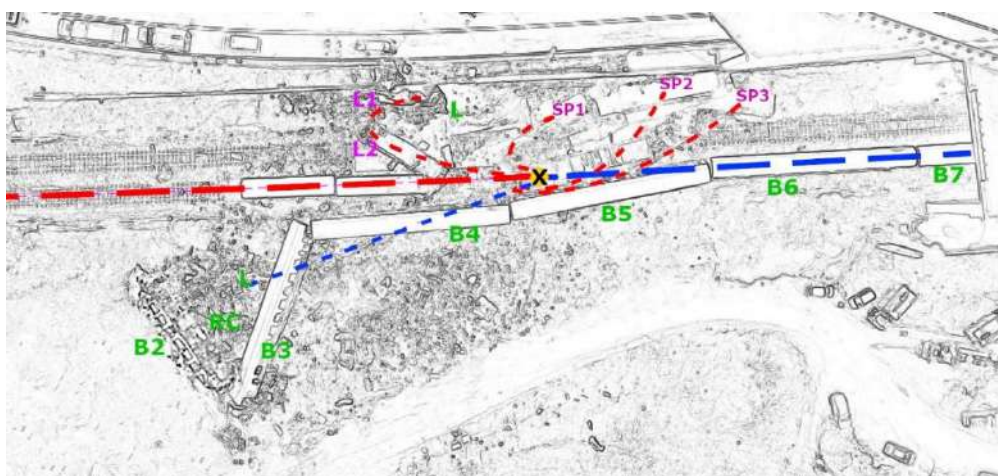
- 130 The 1st phase mainly involved the first 4 vehicles of the two trains: 2 locomotives 120-022 (first) and 120-012 (second) of the freight train and the locomotive 120-023 with its first-class A1 coach. The initial impact is a head-on collision between passenger train locomotive 120-023 and the first freight train locomotive 120-022, that causes the latter, along with the second locomotive 120-012 to be catapulted towards their left over the upward line track and smashed against the motorway wall, with the second locomotive making a U-turn and its rear end sliding over the steel plates carried on the 3rd platform of the freight train to come to a standstill with its front side against the first locomotive and its rear end resting against the first shipping container carried on top of the 4<sup>th</sup> platform of the freight train (Figure 10, Figure 11, Figure 12).

Figure 11. Global movement of the collision, with the initial impact and catapult effects. (SP1,2,3 are Steel Plates, and were also catapulted)

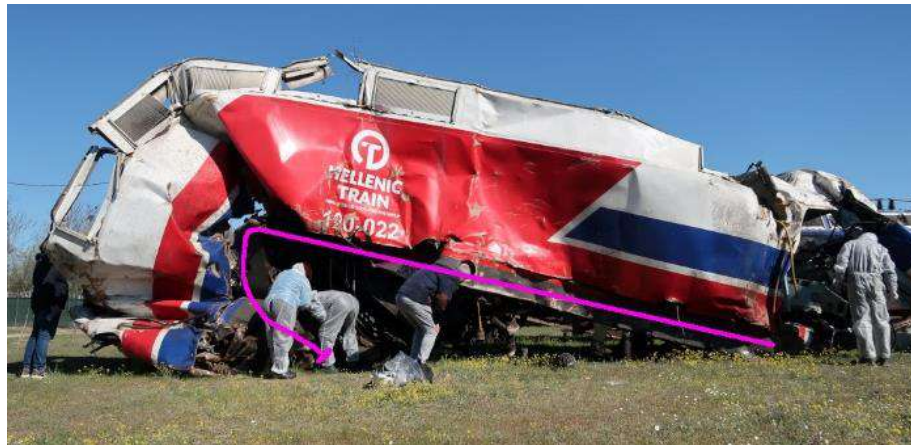
Figure 14. The first locomotive of the freight train (120-022) showing extreme damage from the very heavy head-on collision with the locomotive (120-023) of the passenger train.

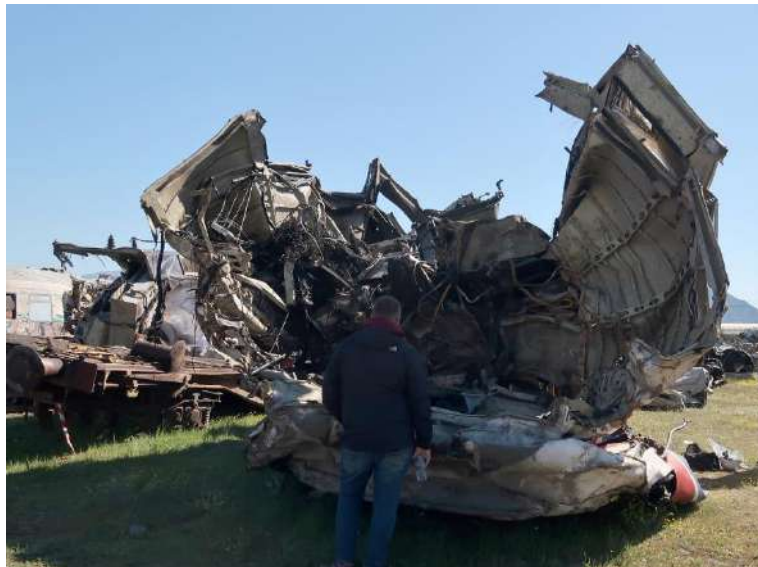
Figure 16. Front view of the locomotive 120-022, roof missing.

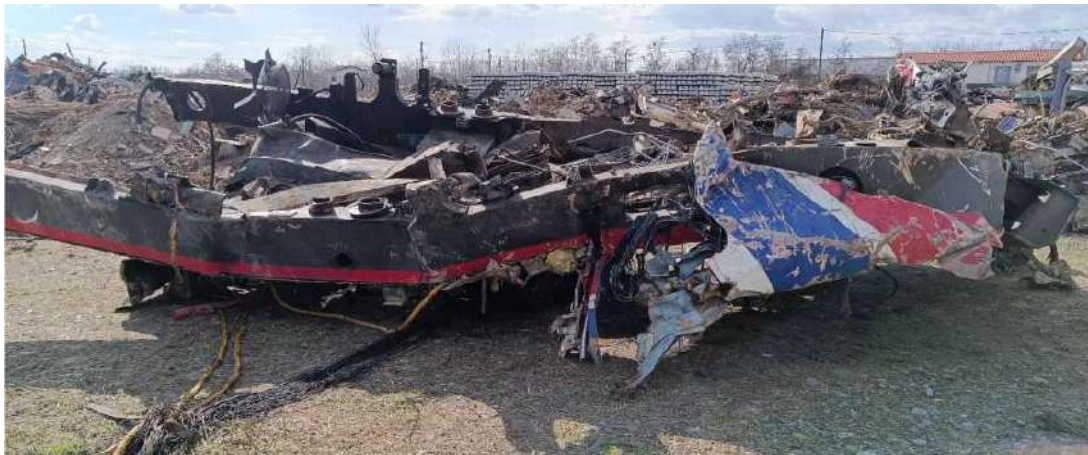
- 132 The passenger train locomotive 120-023 follows a slightly leftward path in its driving direction towards the lower verge, where it hits the ground, followed by the first-class passenger car. Due to the very heavy initial impact, this 120-023 locomotive has been completely destroyed (Figure 17), and its parts were found at an angle of approximately 20 degrees to the left and at a distance of 30 to 45 meters. The A1 coach of the passenger train was completely broken up due to the extreme mechanical loads of the impact and its heavier parts followed a path close to the path of the locomotive parts, at an approximate angle of 25 to 30 degrees to the left. Its lighter parts (seats, internal panels and fittings, luggage, and all casualties) were scattered in a wider area before the end position of the vehicle (see global Figure 12).

Figure 17. Part (chassis) of the completely destroyed locomotive 120-023 of the passenger train IC-62.

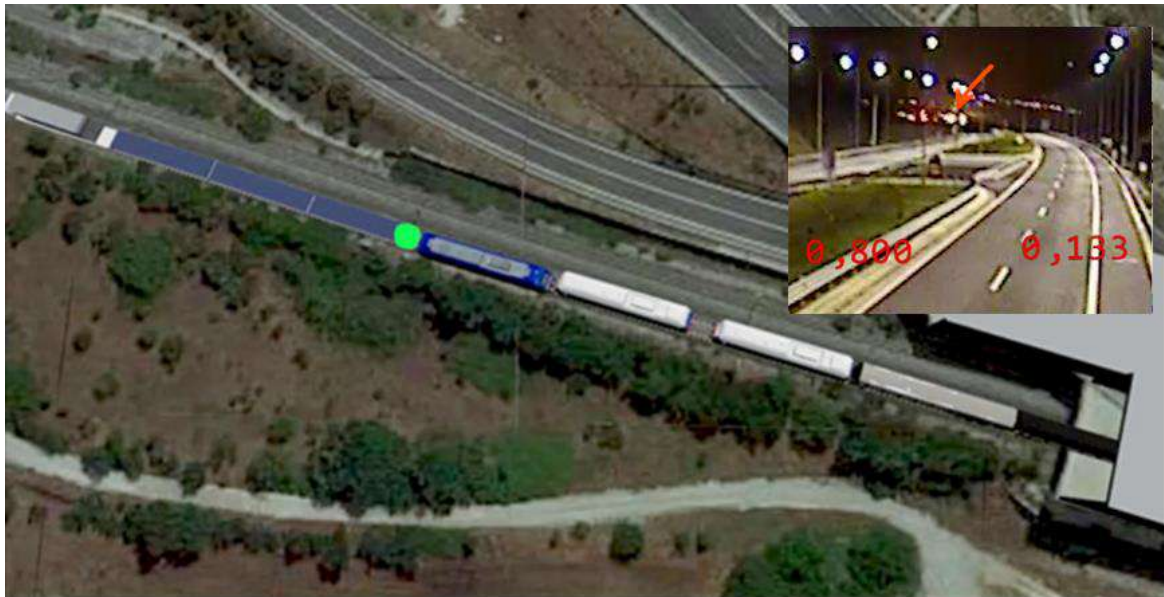
- 134 The second collision is another heavy head-on collision that takes place between the Restaurant Car (i.e. the 3<sup>rd</sup> vehicle) of train IC-62 and an area between the rear end of the locomotive 120-012 and the first of the wagons carrying steel plates (Figure 18). The effort to locate and examine all the remains of the corresponding vehicles of the freight train, shows that it is not possible to locate and identify all these parts.

Figure 18. Estimated area for second collision for the freight train (simulated image behind still of video footage).

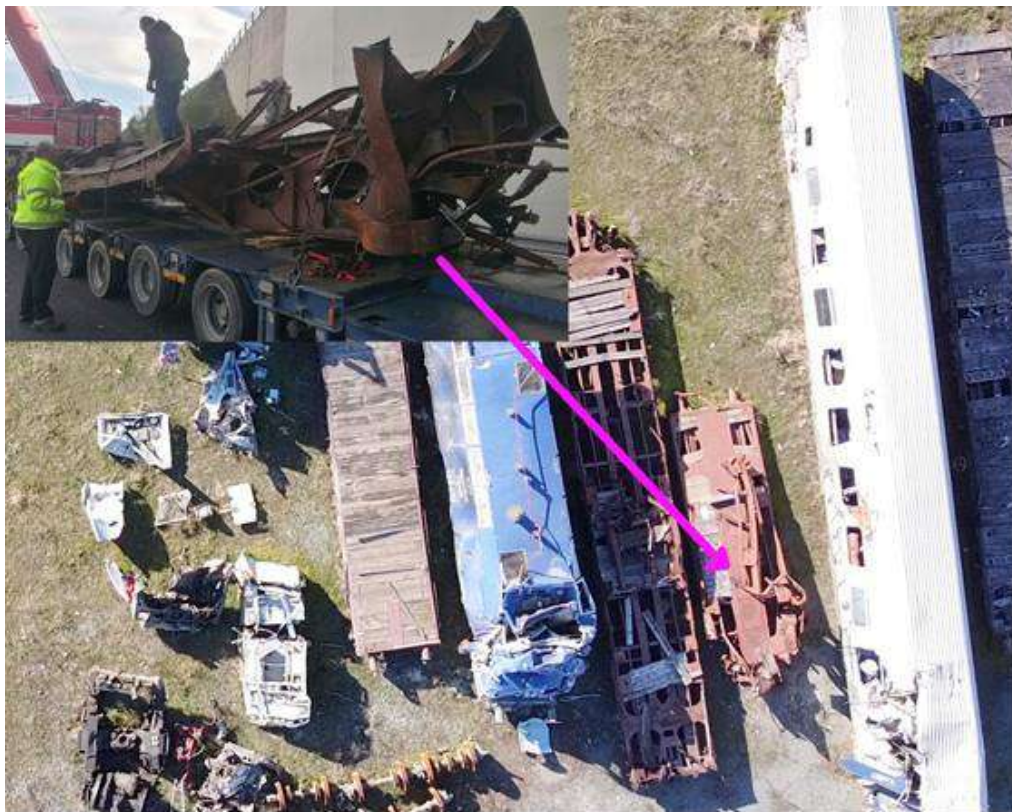
- 135 The rear part of the first platform wagon can be identified among the remains of the vehicles at Koulouri, but the front part is not available for examination, as it was presumably cut in smaller pieces in order to allow easy transport (Figure 19). This action was not documented in any way and there are no photographs of the carriage in its original condition at the crash site before being cut up and moved by an unknown party.

Figure 19. Remains of the first platform that was carrying steel plates.

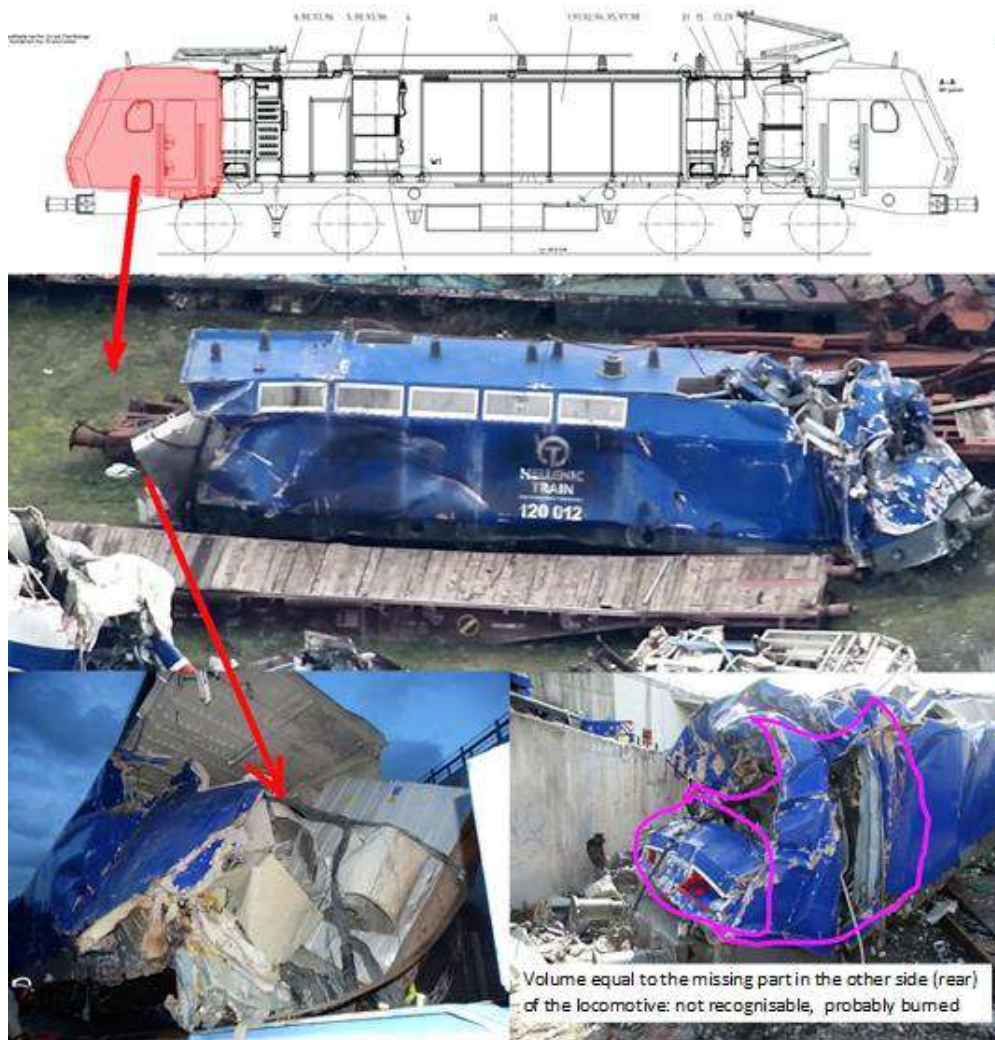
136 The rear driver's cabin of the 120-012 locomotive appears to be cut off from the rest of the vehicle and it cannot be completely identified anywhere among the debris, apart from a small part of its roof and top headlight (in front of the first container). The rest of the cabin cannot be identified as a whole and also the front panel with the painted number and the two red headlights are also not recognisable among the debris. Presumably, the missing structure is among the crashed and burned remains of the Restaurant Car, as this is the only place in the whole accident site where the fire burned so fiercely that it totally consumed the heavy industrial-grade paint of the blue locomotive, making it unidentifiable.

Figure 20. Missing rear-end of the locomotive 120-012.

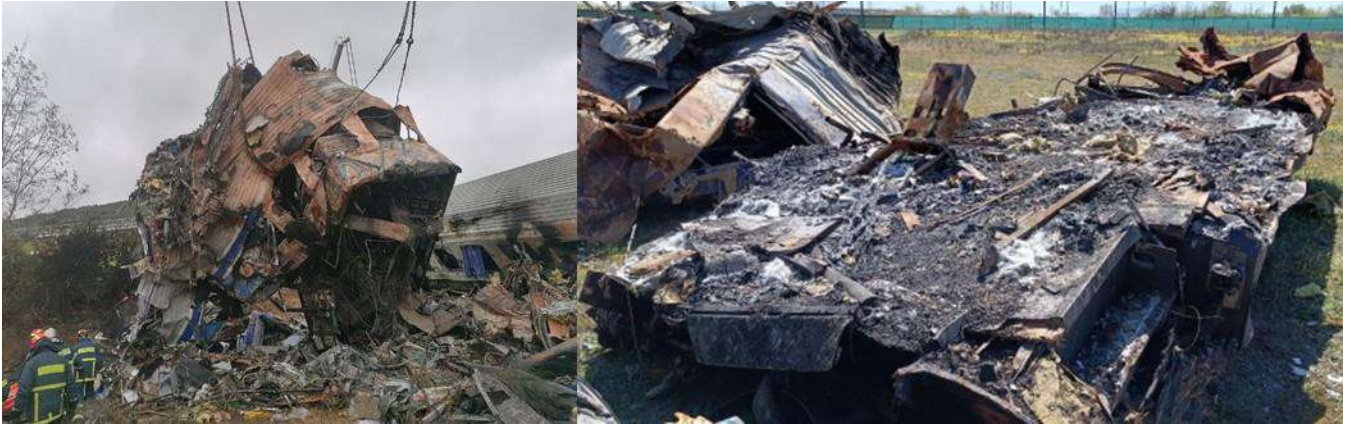
137 This second collision causes very heavy damage to the Restaurant Car (Figure 21) that is bent into an S-shape mostly due to this initial impact but also sustaining damage while rolling and hitting the ground on its way to the lower verge, to end almost on top of the remains of the locomotive 120-023 and the destroyed A1 first-class coach.

Figure 21. Remains of the Restaurant Car, on the left, S-shaped as found on-site, and on the right, its platform at Koulouri site.

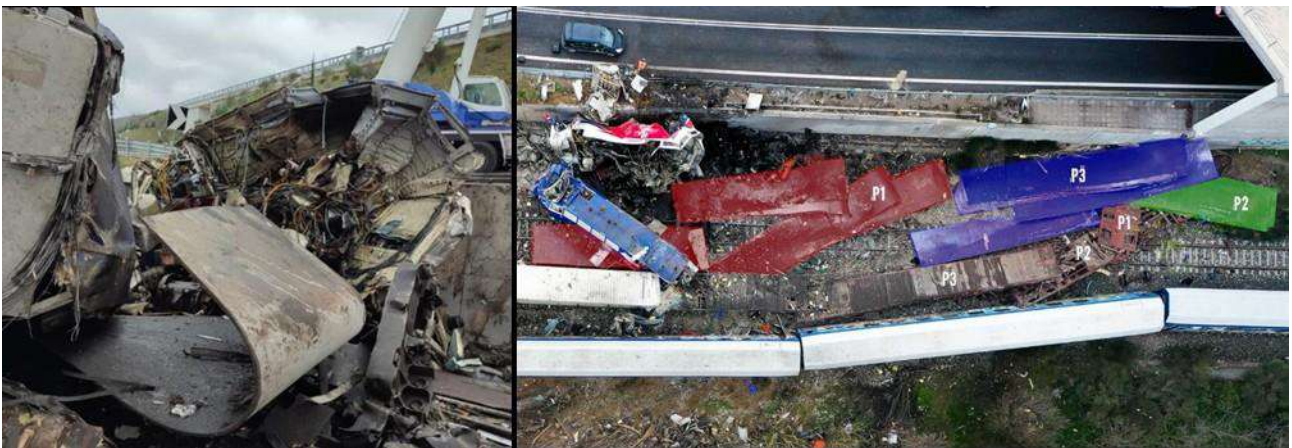
138 By comparing the damage to the steel plates and the Restaurant Car, it can be considered as most likely that the initial impact to the Restaurant Car came not on its front bumper but underneath its “belly”, indicating that the Restaurant Car had a slightly “nose-up” attitude at the moment of the impact, which is consistent with the damage observed on the first and presumably topmost steel plate that was found wedged underneath the blue 120-012 locomotive. Meanwhile, the 1st platform of the freight train sustains very heavy damage from the impact with the Restaurant Car that leaves it bent in half and wedged under the remaining steel plates against the wall, and spread few meters after the collision, in the area before the entrance of the tunnel. (Figure 13, Figure 22).

Figure 22. Remains of the top steel plates and final position of the 3 sets of steel plates.

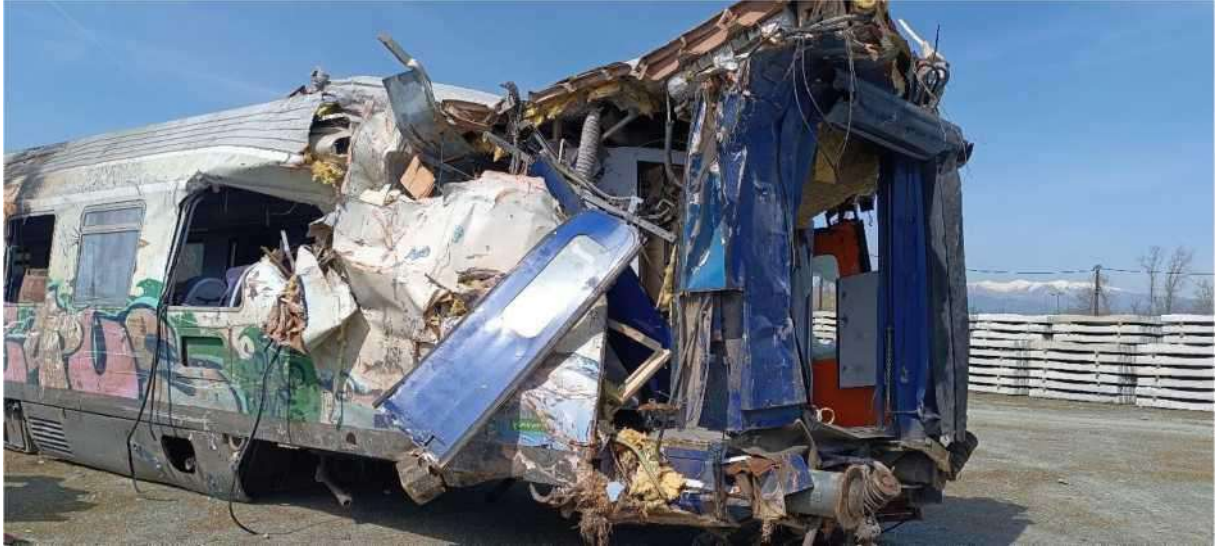
140 Derailed by the collision of the Restaurant Car, the B2 vehicle (a passenger coach divided into 11 6-seat compartments) continues straight ahead with a slight angle to the train tracks, nose diving downwards and hitting the ground with its front end, bending and breaking off its front section in the middle of compartment no 2. After the head-on impact, the rear of the wagon is lifted high and to the left and coming down to hit the front of the B3 passenger coach.

*Figure 23. Remains of the B2 coach*

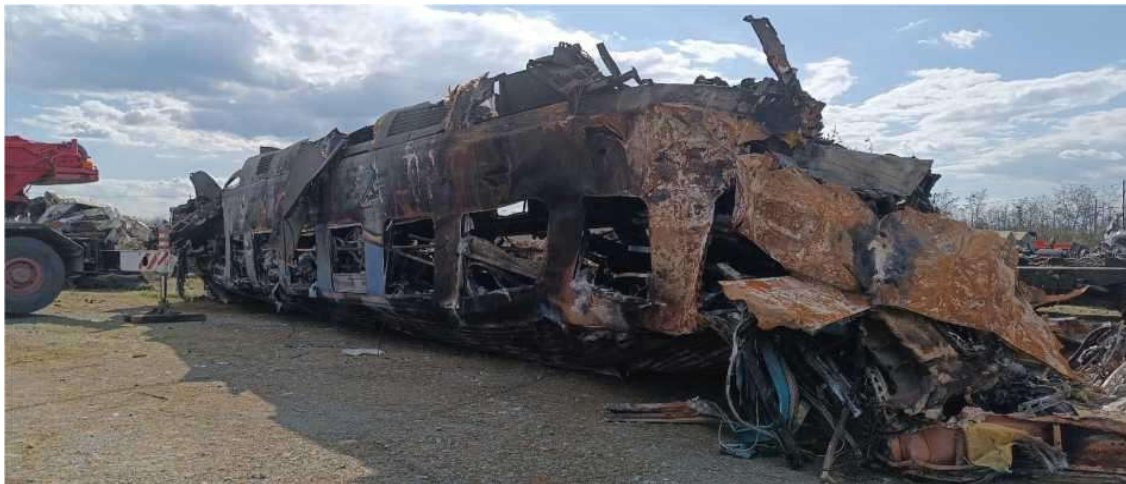
- 141 This B3 coach, in the meantime is derailed and veering to the left, its front end moving downhill and cutting down small trees and bushes, while its rear end is pushed straight ahead by the B4 coach (still attached to each other), creating a rotation to the left for the B3 carriage that comes to a stop at an angle when its side hits the debris of the A1 coach and the broken up Locomotive.
- 142 The impact of the B2 (Figure 23) on the top of the B3 wagon (Figure 24) causes the rear part (11th compartment) of the B2 coach to break off and fall below, while at the same time it causes severe damage to the B3 coach underneath.

*Figure 24. Remains of the B3 coach*

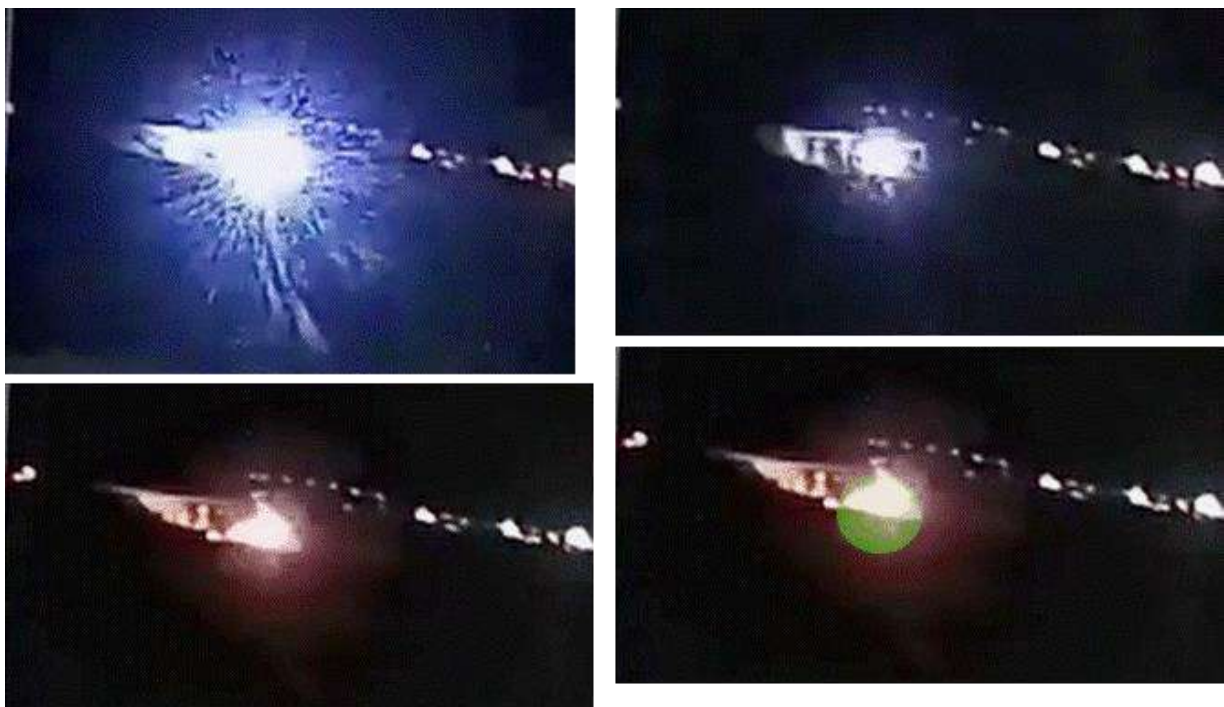
- 146 A first stage that can be observed, the ignition and creation of a fireball, starts at approximately 0.6 seconds after the initial contact between the locomotives of the two trains, when a first electric arc is being recorded on video. A short circuit is created with a bright flash due to the electric arc; and another 2 flashes appear rapidly after, each approximately 0.1 second apart. These 3 bright flashes stop after a total duration of about 0.3 seconds, which is consistent with the expected timing of the tripping of the automatic overload protection that was (manually) recorded at the power control station that remotely monitors all data at Thessaloniki.

Figure 27. First stage, arc flash and ignition. The green circle shows the theoretical expansion radius of the initial deflagration.

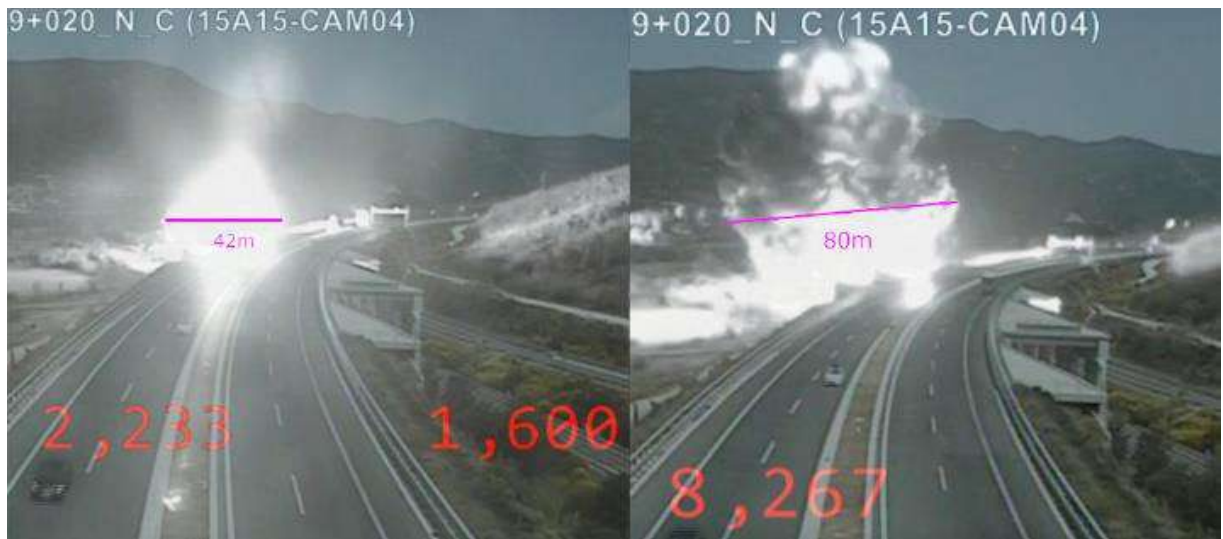
- 147 At the same time, the catenary lines themselves (both lines, one for each direction of travel) have been ripped off due to the collision, but the power was already cut within 0.2-0.3 seconds of the short circuit. Approximately 0.3 seconds after the end of the arc flashes, a fireball starts forming from the ground level and very rapidly expands upwards to a size of approximately 42 meters in diameter, which burns for approximately 2 seconds.
- 148 At approximately 2 seconds after the initial ignition, a second stage starts, when a new fire plume can be observed, moving northbound, away from the 1<sup>st</sup> stage fireball. This new fire plume is feeding the original fireball until it grows to almost double the size (80 meters) at approximately 4 seconds after ignition (Figure 28, Figure 29, Figure 30).

Figure 28. First (left) and second stage (right) of the fireball.

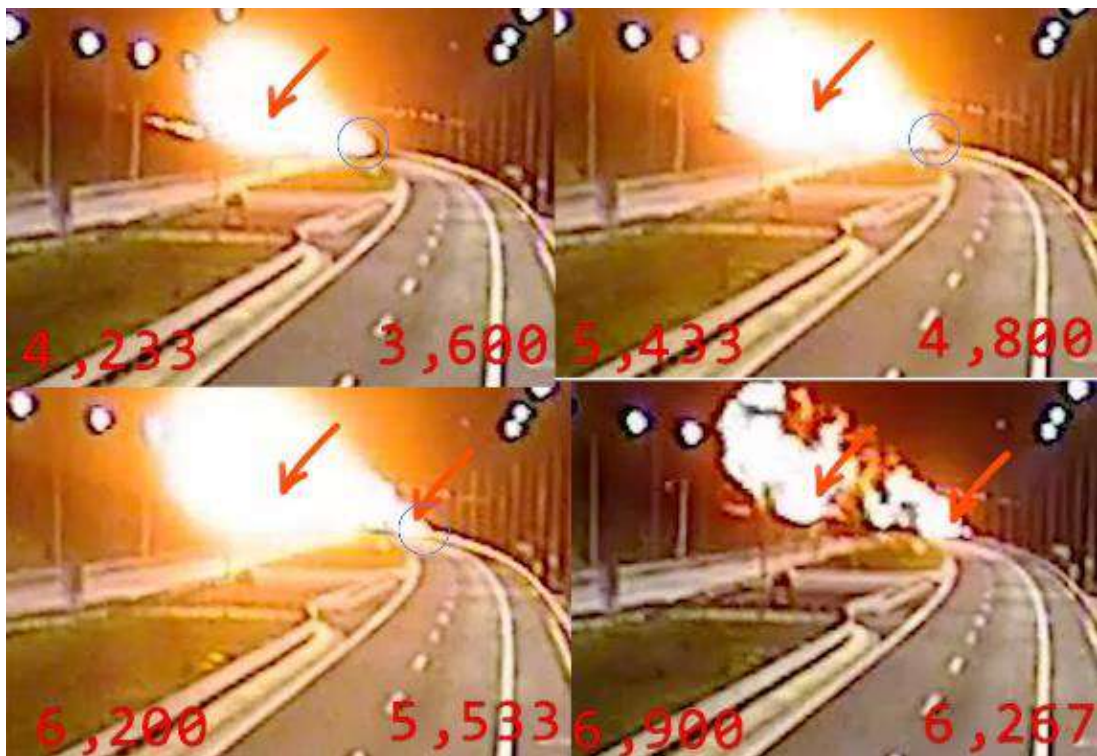
Figure 29. Second stage, fireball (left side of pictures) and fire plume (right side of the pictures)

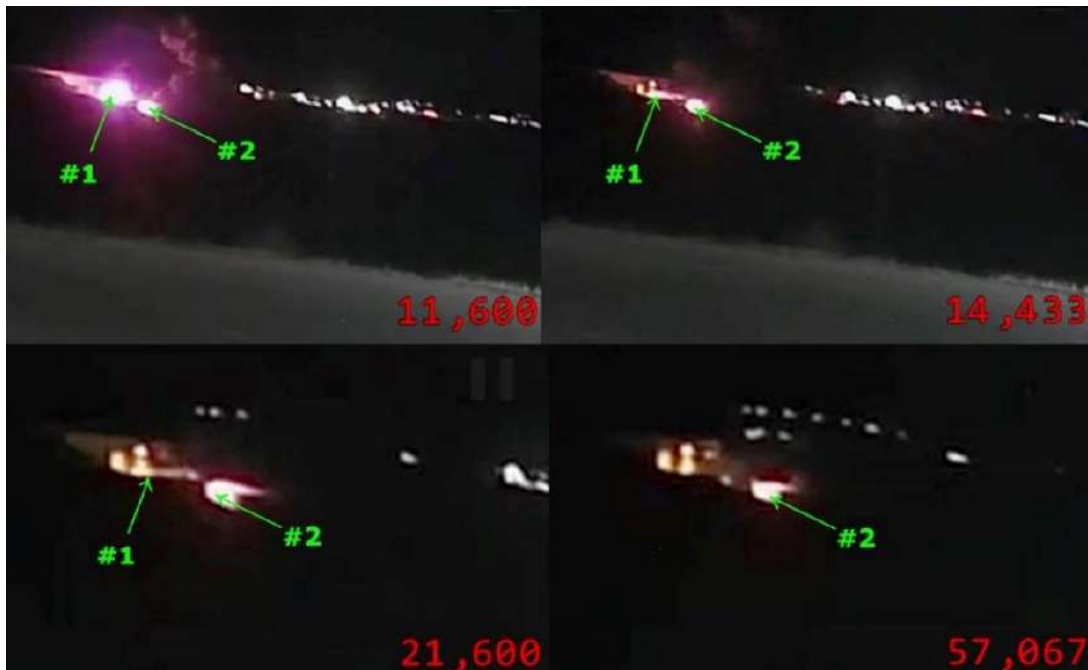
Figure 31. Pool fires #1 and #2

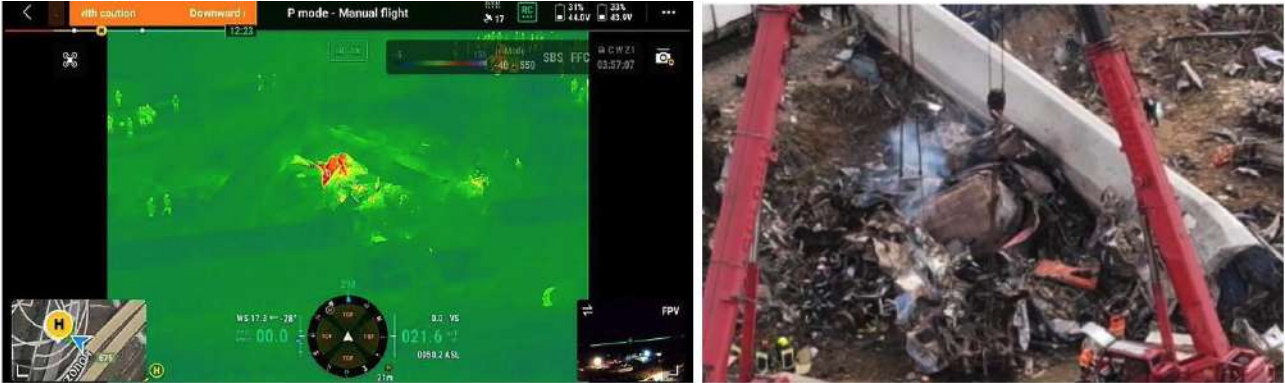
Figure 32. Fire simmering inside the Restaurant Car for 12 hours.

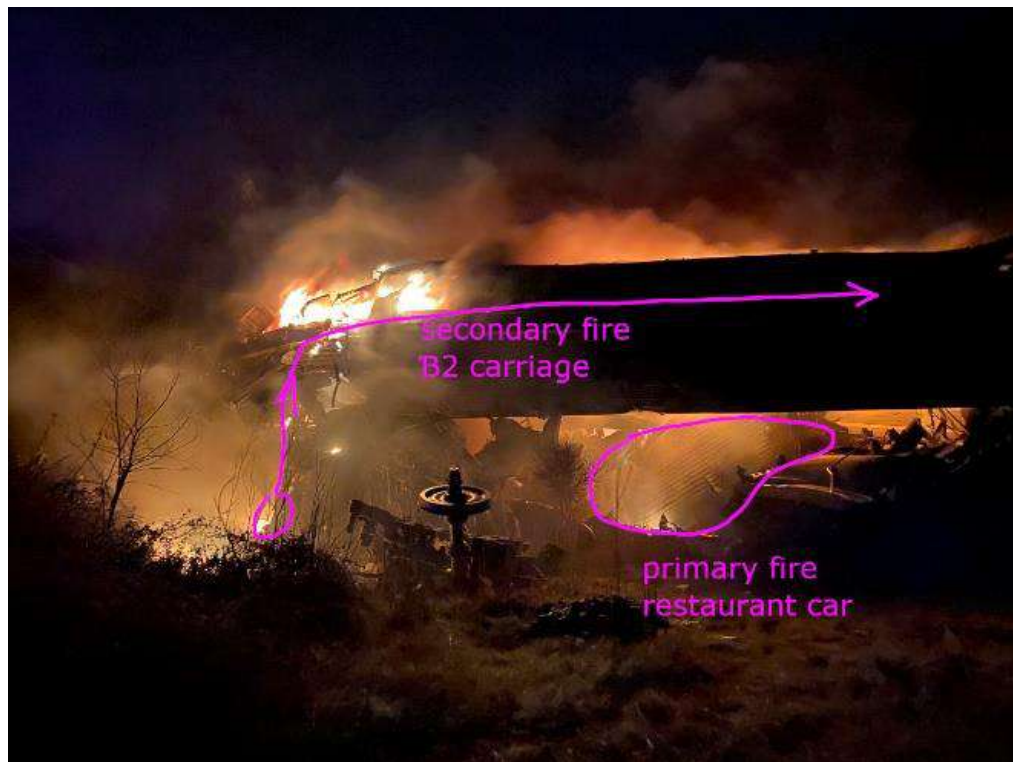
Figure 33. Another fire started at the front of the B2 coach.

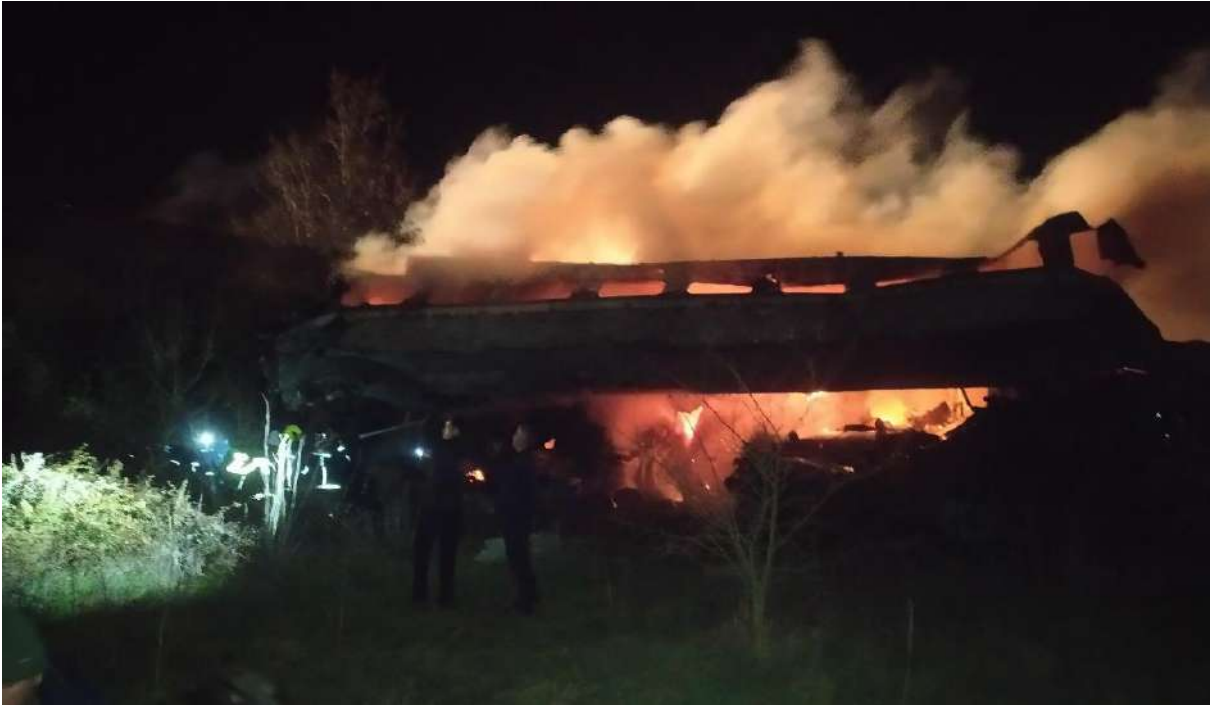
Figure 34. Photo showing the heavy fires in the Restaurant Car area (behind), and on the B2 coach (front, above) (Source: EDAPO).

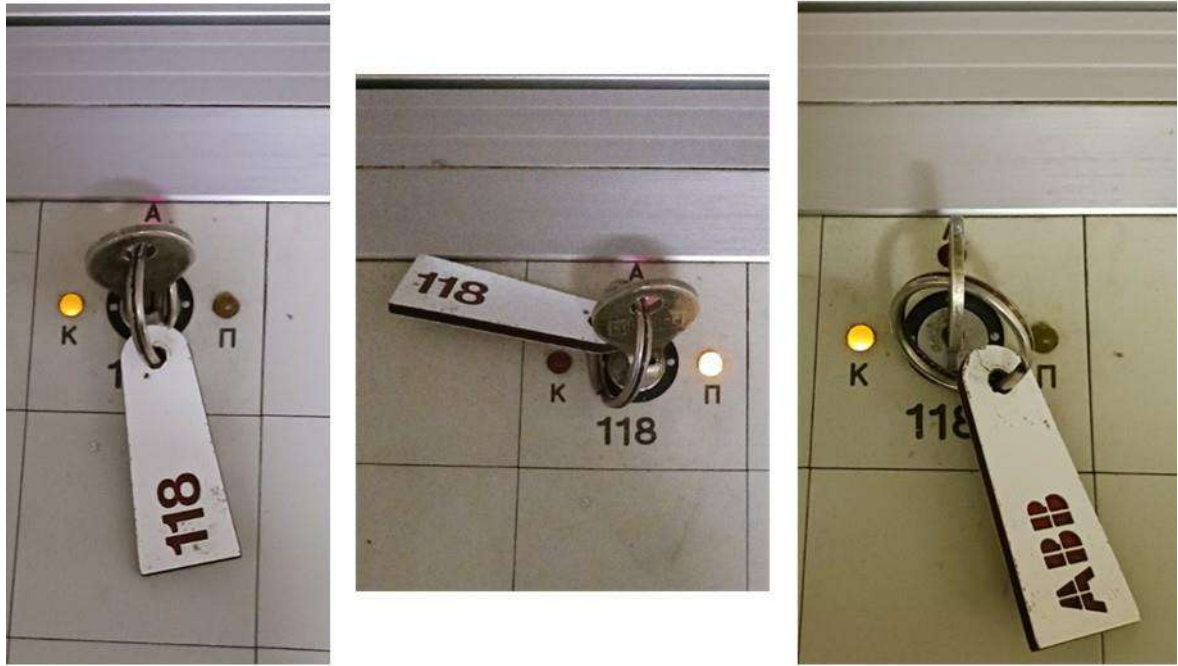
Figure 46. Detail of the three-position key for handling switches 118 on the Larissa Control Panel.

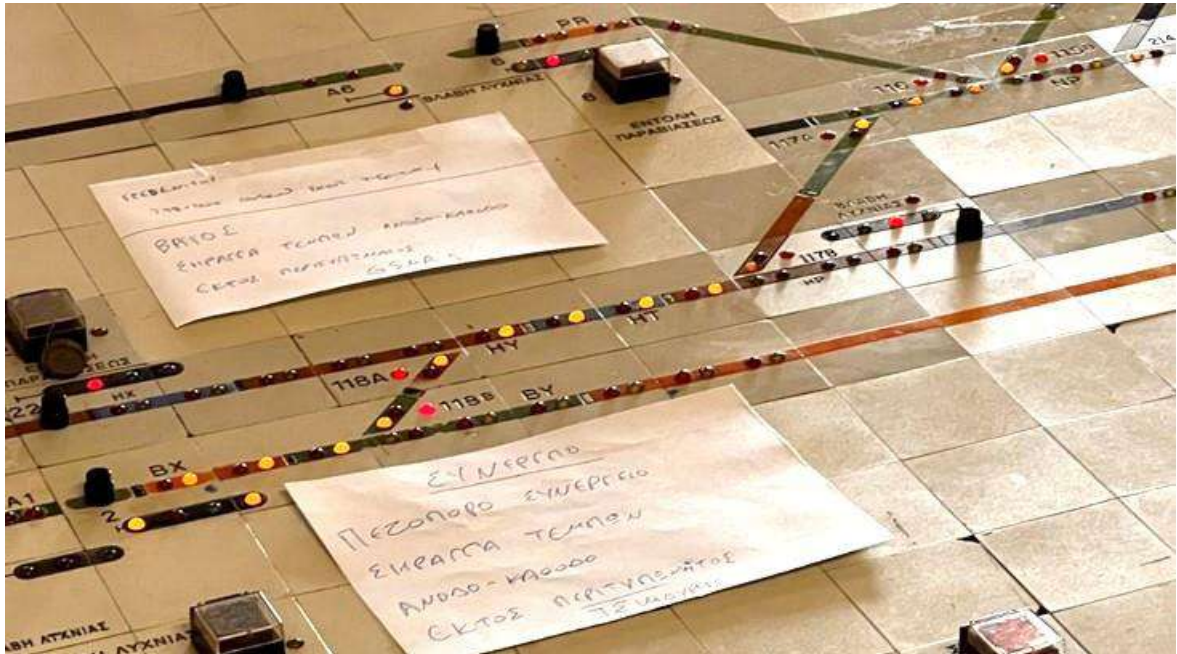
Figure 48. Detail of the Larissa Control Panel with a route set to cross a switch in a bypass position.

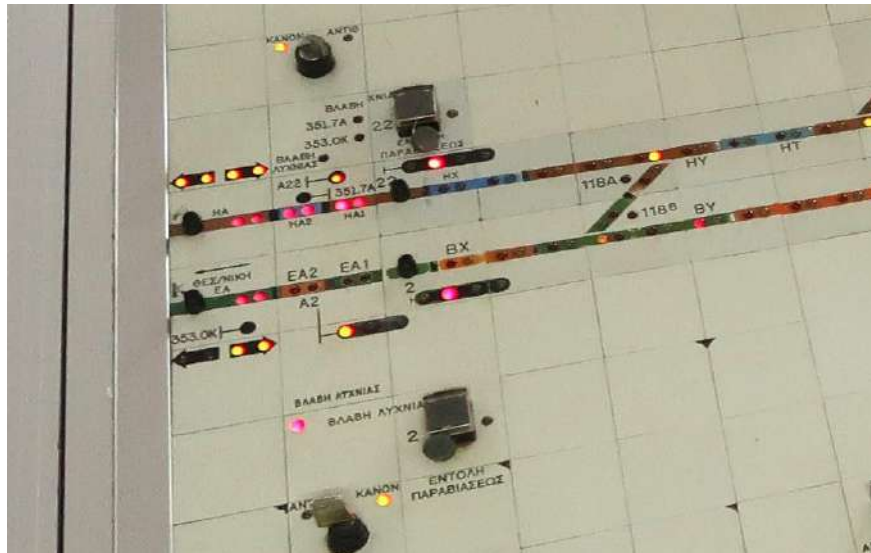
Figure 49. Section EA3 (indicated EA to the left of EA2 on the picture) of the control panel incorrectly indicating an occupation.

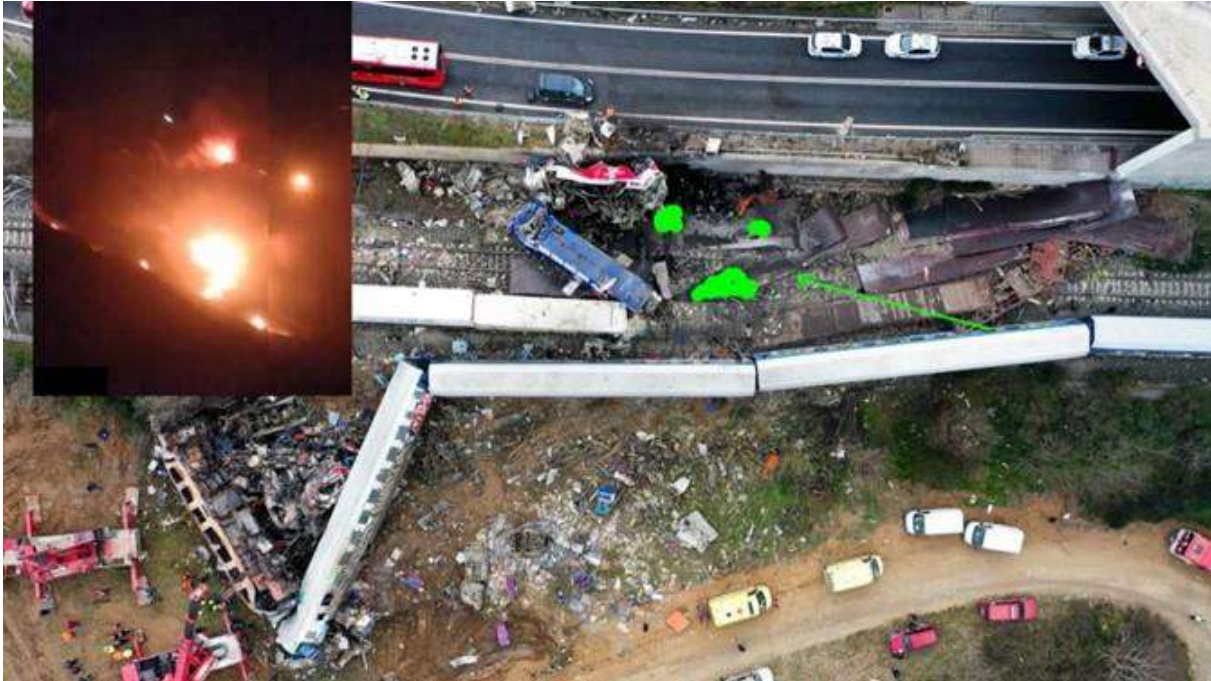
Figure 64. Fire inside the transformer of freight train as a secondary result of pool fire #1.

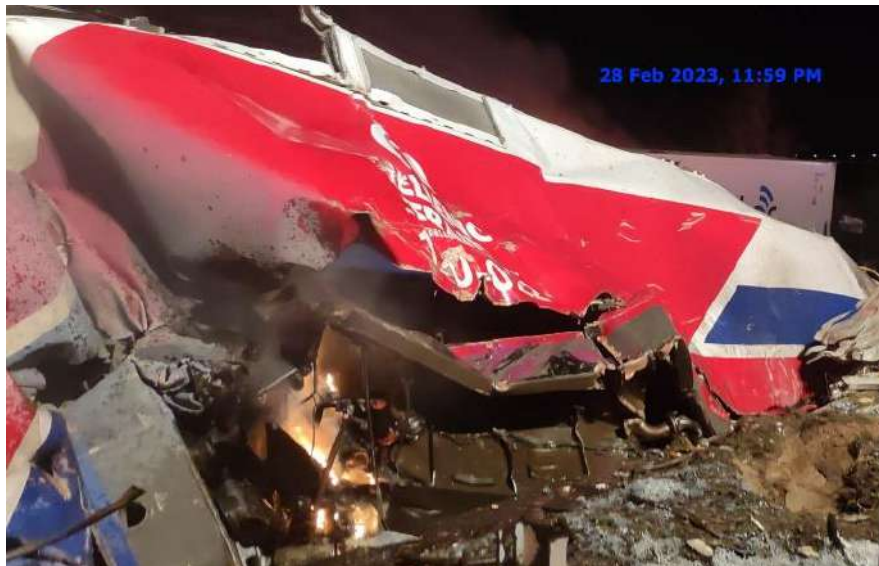
Figure 65. A local fire inside and outside the broken transformer of the first locomotive of the freight train, 40 minutes after the accident.

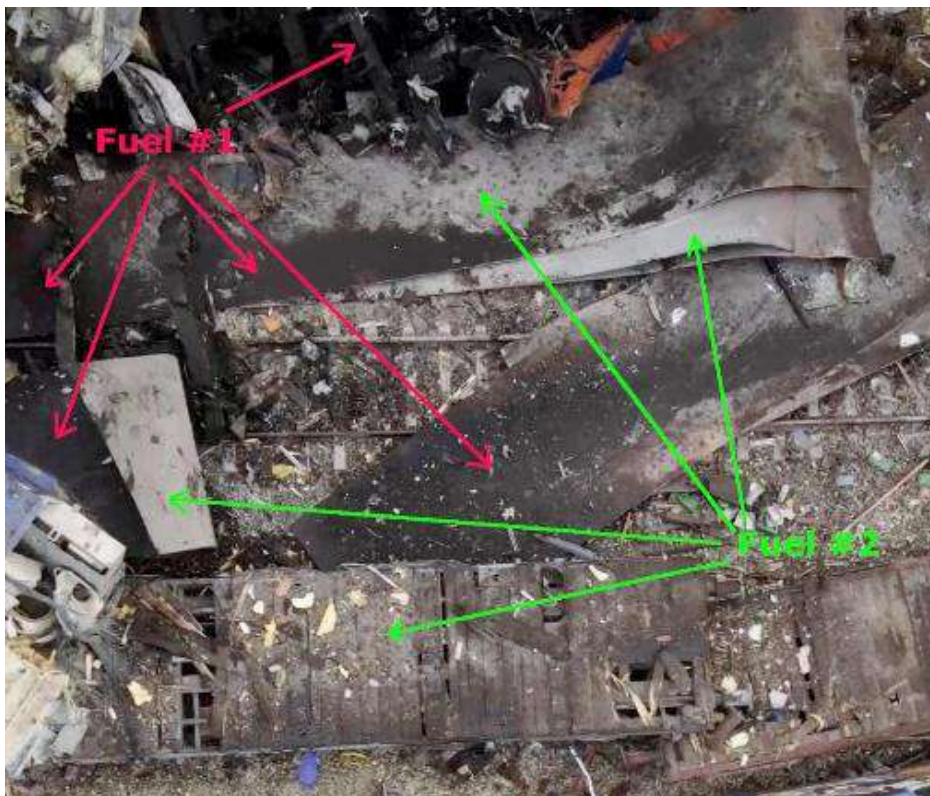
Figure 66. Evidence of two different fuels burning in the pool fire #1, one leaving black, the other leaving white residue.

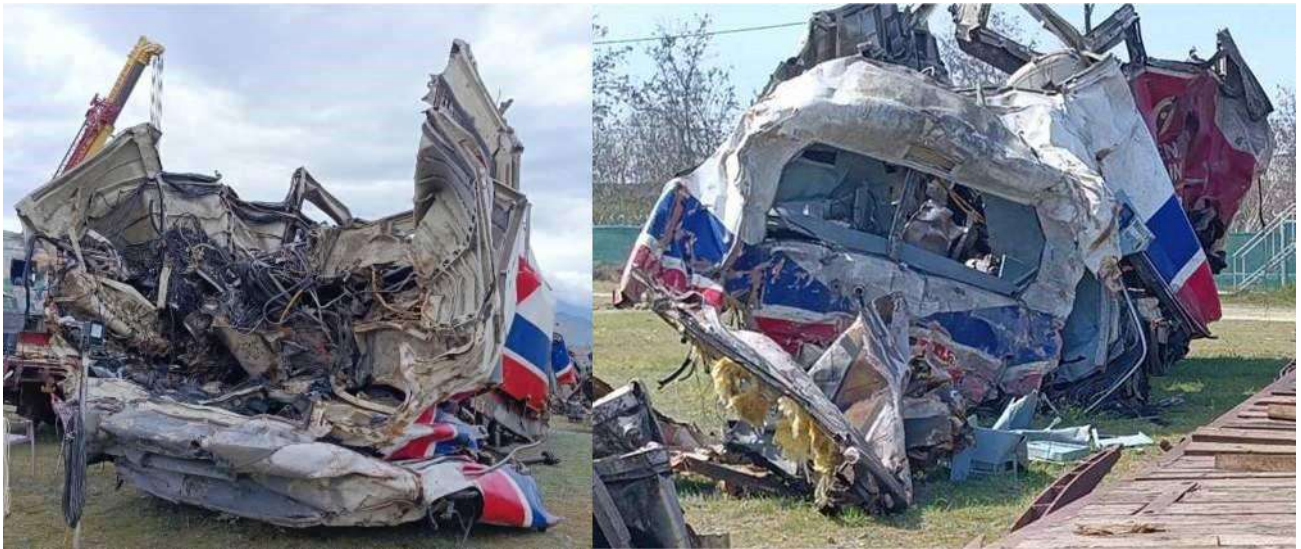
Figure 77. Position 1) Siemens Hellas Sprinter 120-022- NVR Engine: 91 73 212 0 022-7 Extreme damage on the front, roof missing, and rear heavily damaged from the rear collision with the attached locomotive 120-012. Rear view in Figure 14.

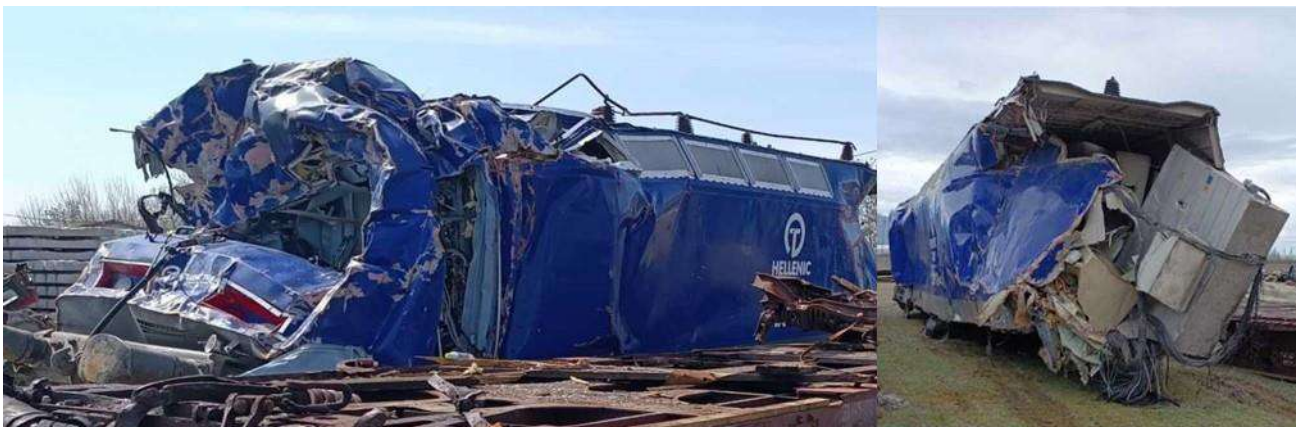
Figure 78. Position 2) 120 012 locomotive, heavy damage in the front (with locomotive 120-022) and rear, signs of crash against 1st container on P4, without the missing rear cab.

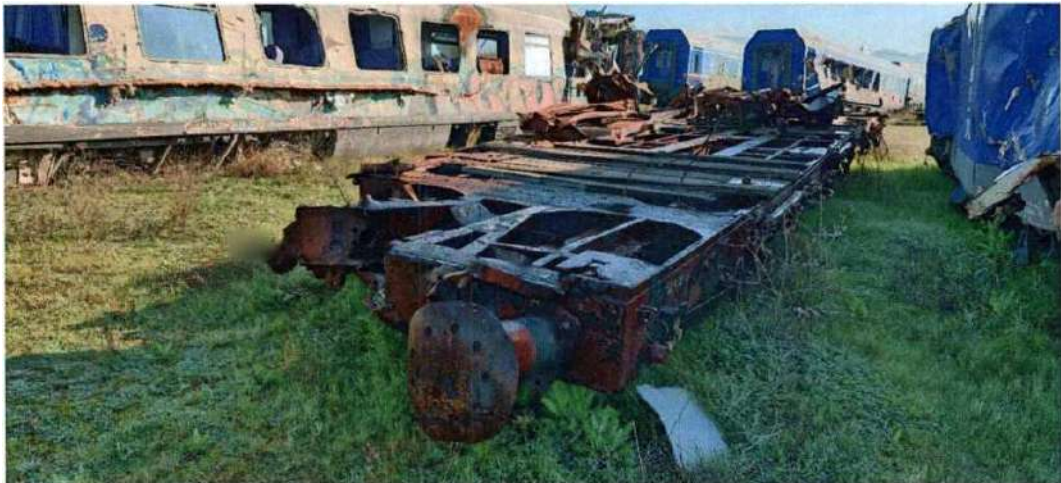
Figure 79. Position 3) nr 1 platform carrying steel plates, front half totally destroyed by heavy impact with Restaurant Car.

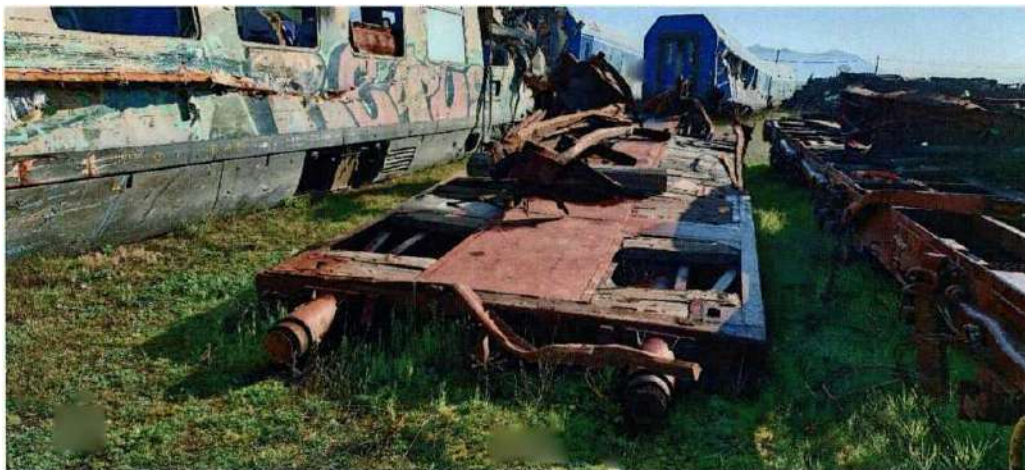
Figure 80. Position 4) nr 2 platform carrying steel plates, lost bogies from derailment but very slightly damaged, no signs of heavy crash.

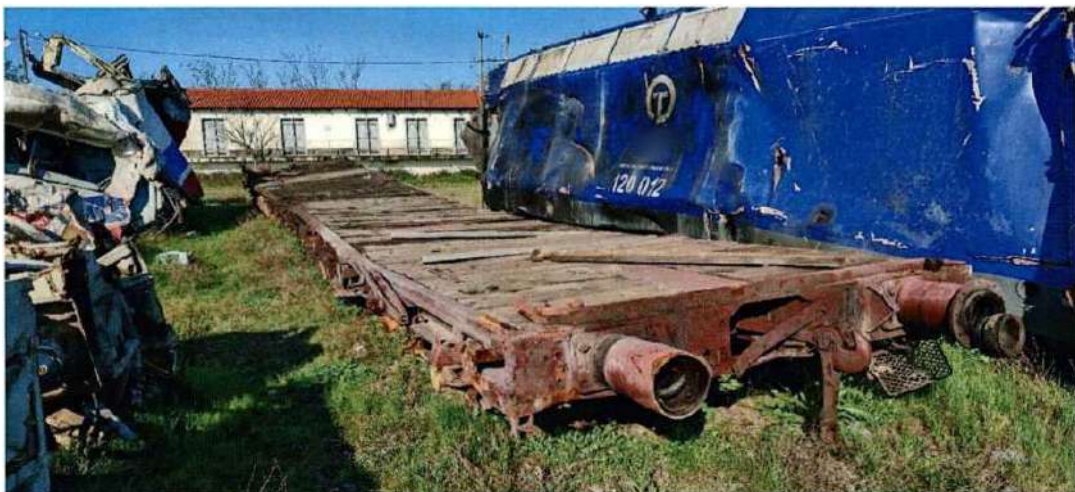
Figure 81. Position 5) nr 3 platform carrying steel plates, lost bogies from derailment, slight damage (twist) due to crash from the rear.

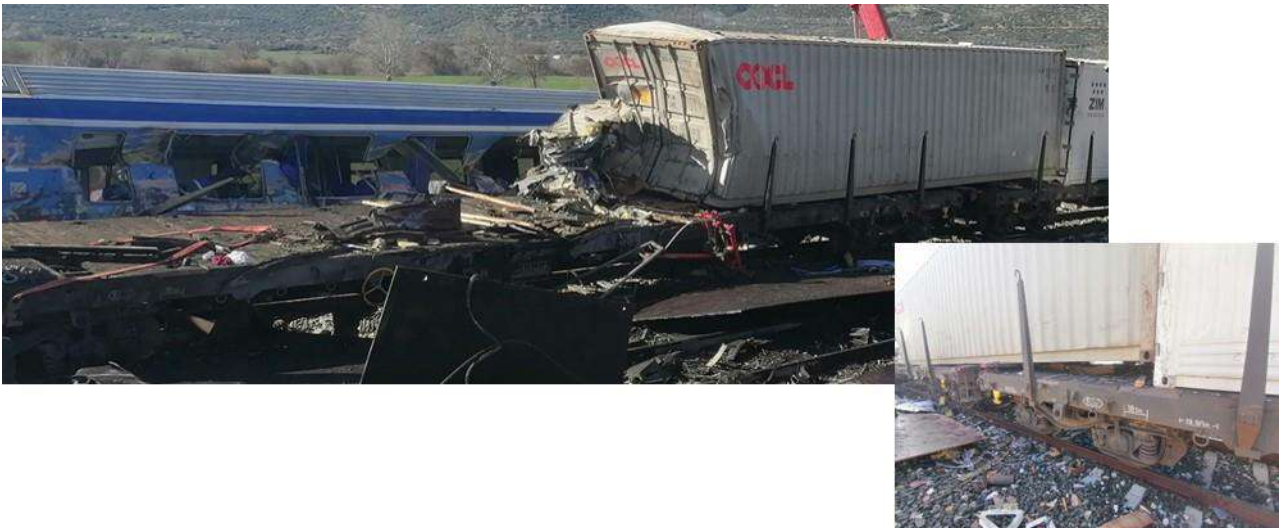
Figure 83. Positions 6) and 7) – on the left, the platform nr 4 (damaged, lost front bogie, not derailed) carrying the first container. On the right, the first container (OOCL) is shifted in rear direction, hurting the next container (ZIMonitor).
