**HARSIA**  
Hellenic Air & Rail  
safety Investigation Authority

Rail Accident Report

Head-on collision between a passenger train and a freight train  
in Tempi, 28 February 2023

RL01-2025, 27 February 2025

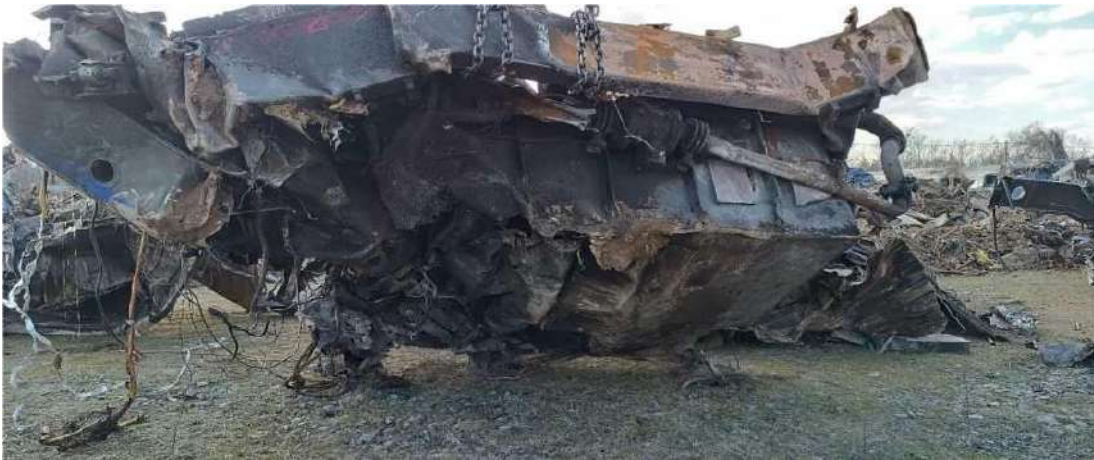
Figure 85. Position 1) 120 023 locomotive, totally destroyed, broken into large pieces. Remaining piece of the basement platform. Part with transformer still visible. Other side in Figure 17. At the position 2) the A1 1st class coach, totally destroyed, has broken into small pieces, and was not recognisable as a whole vehicle.

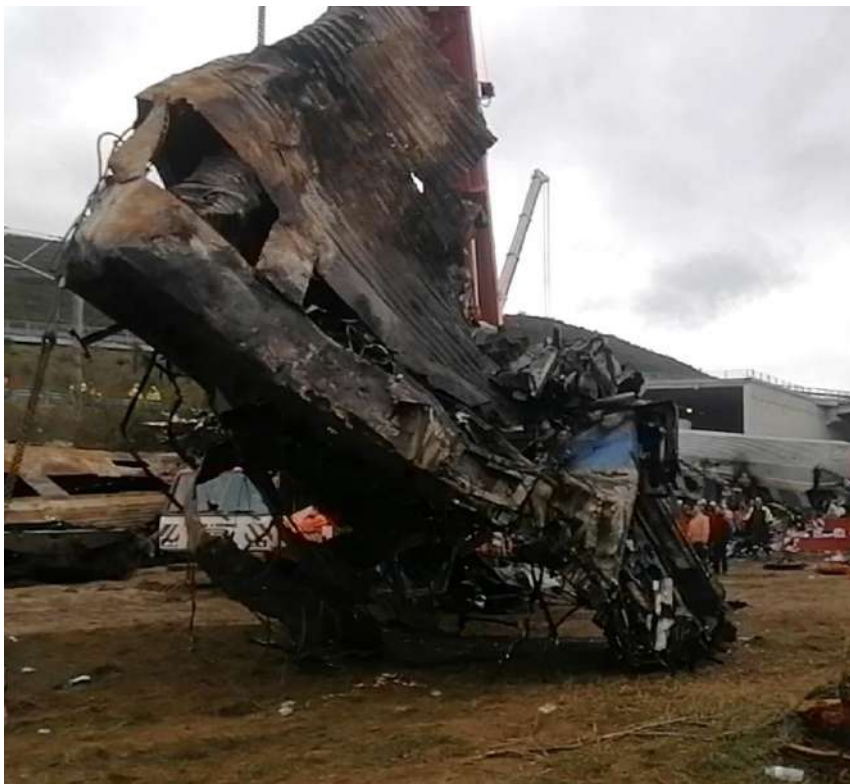
Figure 86. Position 3) Restaurant Car, very heavily damaged from initial crash (folded, bent into S-shape) and burned down. Here, suspended from the crane cables.

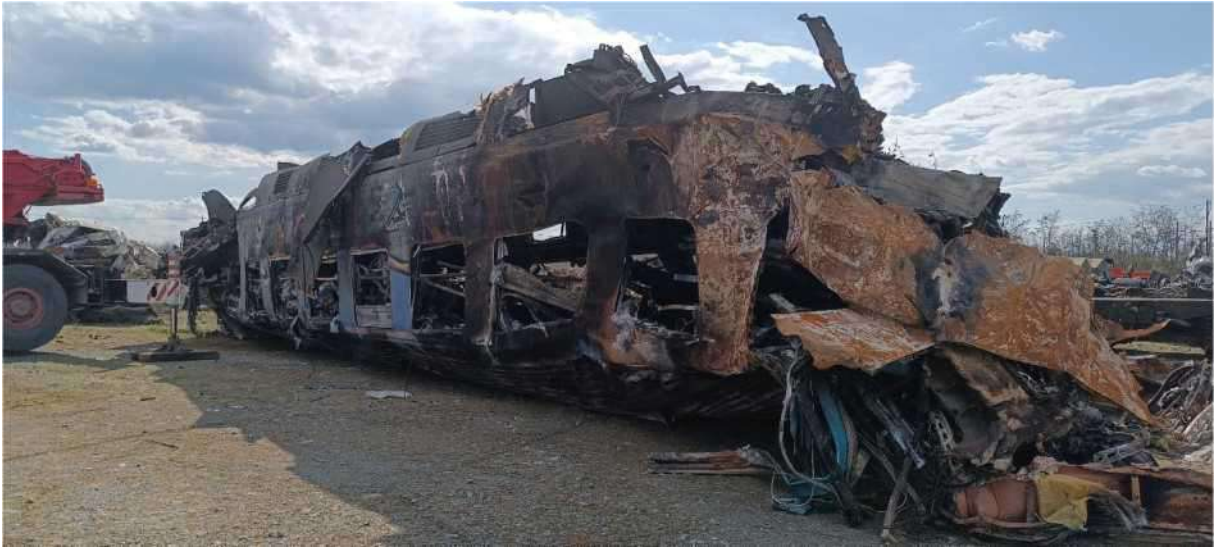
*Figure 87. Position 4) B2 2nd class coach, heavy impact damage in the front and rear, fire slowly consumed it.*

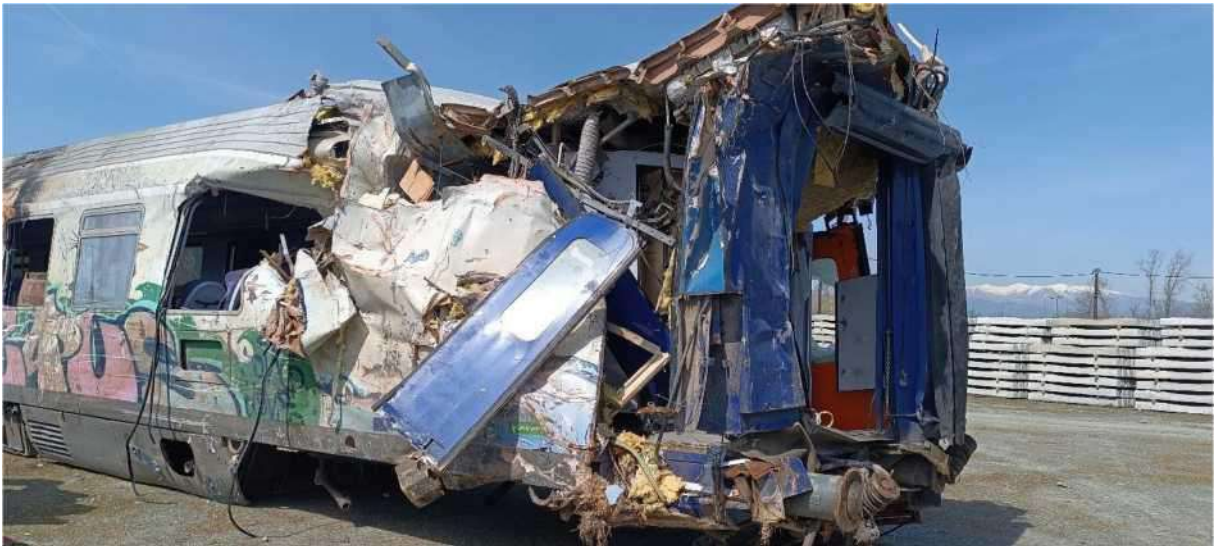
*Figure 88. Position 5) B3 2nd class coach, derailed and went down a slope, lost bogies, no other damage from derailment or crash, specific impact damage from B2 coming down from above.*

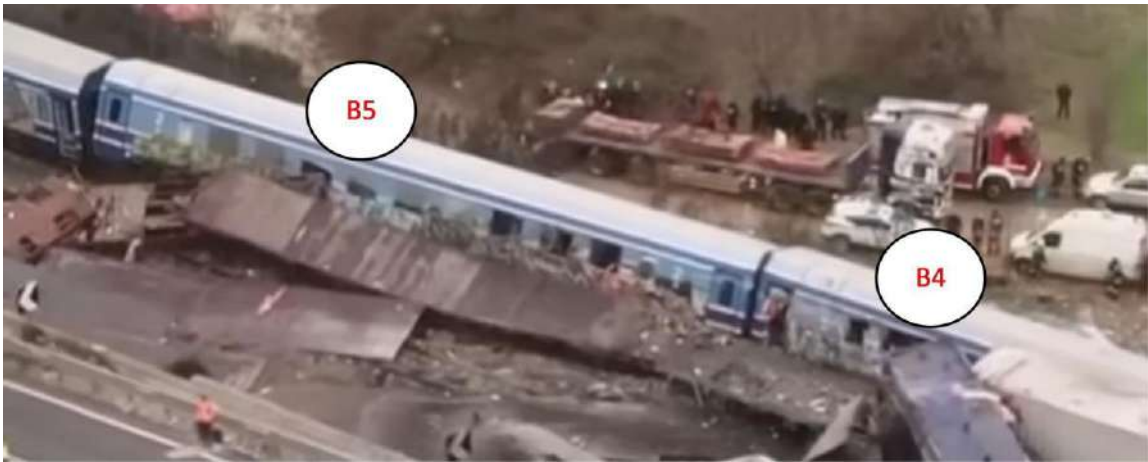
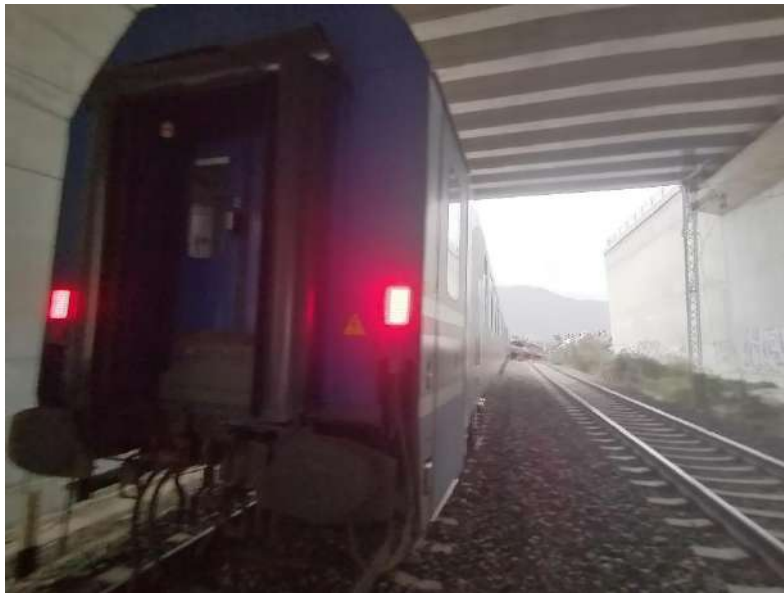
*Figure 89. Positions 6-9) B4-B7 coaches, B4 and B5 derailed and were hit on the side by steel plates, B6 and B7 did not derail, no damage, B7 remained nearly all in the tunnel.*
