**HARSIA**  
Hellenic Air & Rail  
safety Investigation Authority

Rail Accident Report

Head-on collision between a passenger train and a freight train  
in Tempi, 28 February 2023

RL01-2025, 27 February 2025

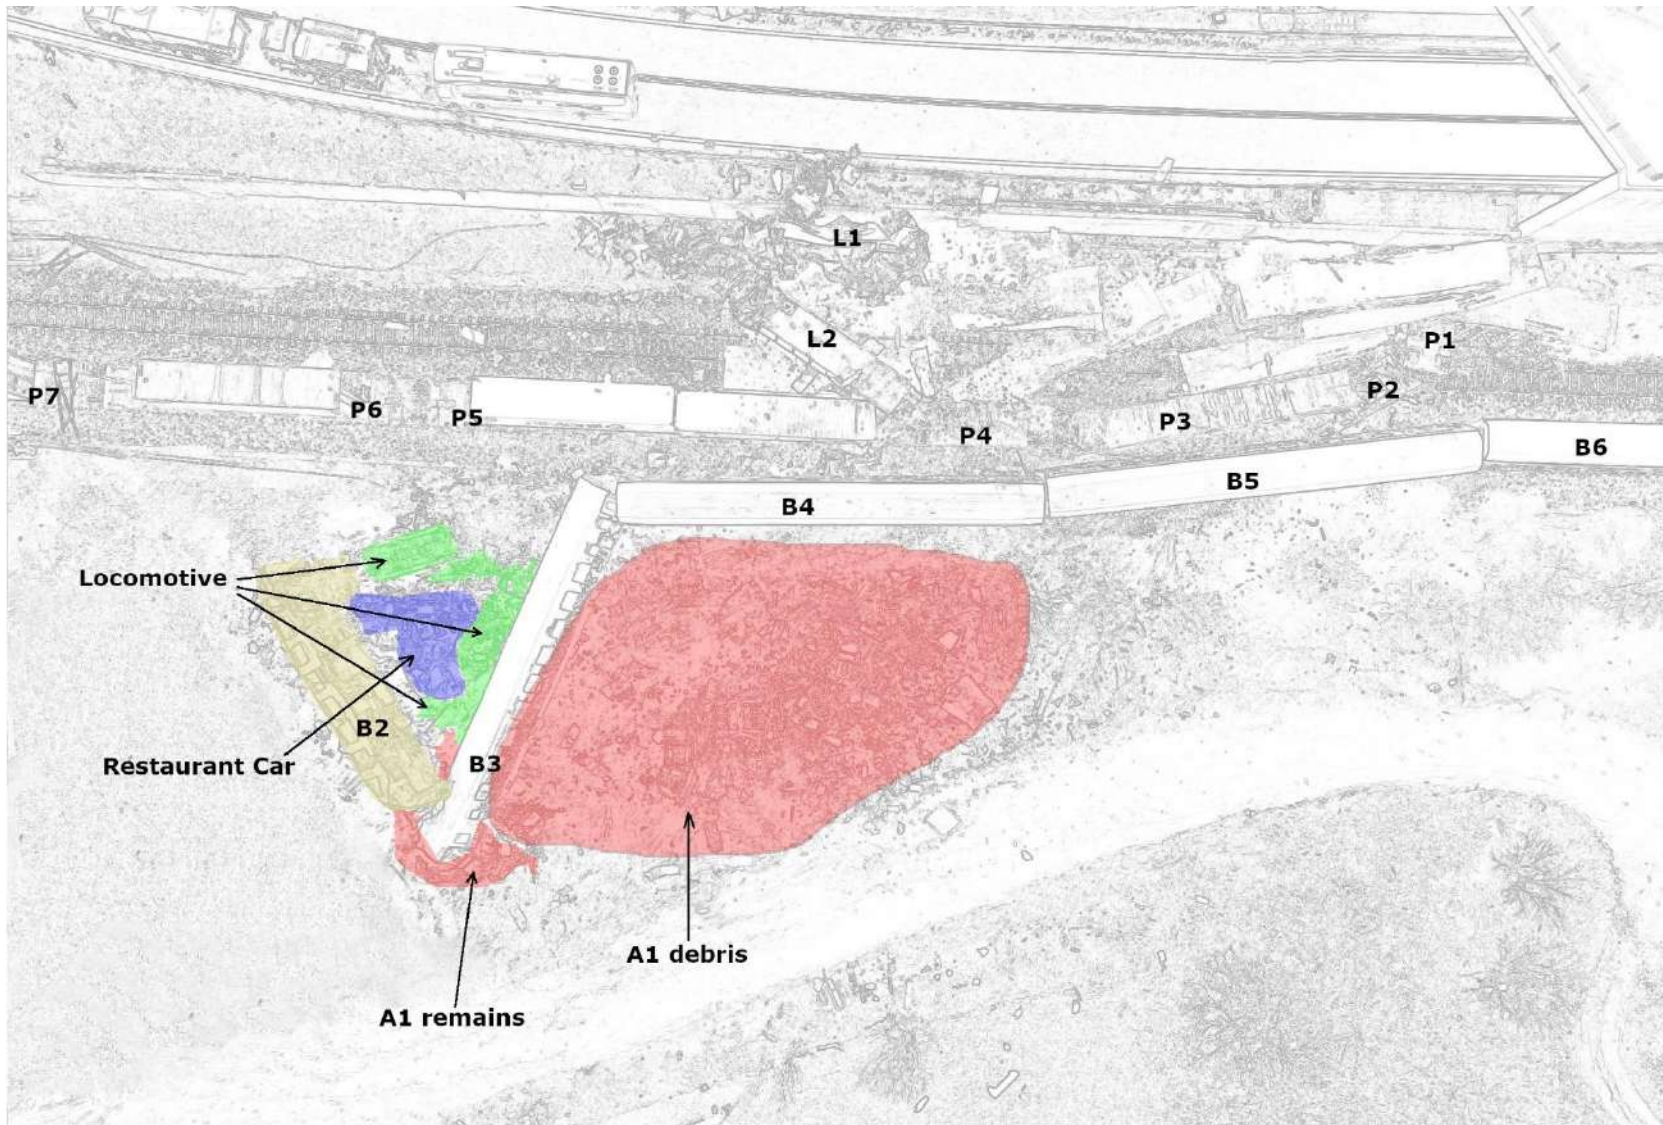
Figure 12. The accident site.

Best estimated point of the 1<sup>st</sup> collision: X, Freight locomotive 120-022: L1, and 120-012: L2, Passenger train locomotive 120-023: **Locomotive areas**, First-class A1 coach: **A1 areas**, **Restaurant Car** area, Second-class B2 on B3 head, then B3, B4, B5, B6, (B7 under the tunnel), Freight train platforms P 1-2-3-4, and freight wagons 4-7 (and other 6 not on the figure).

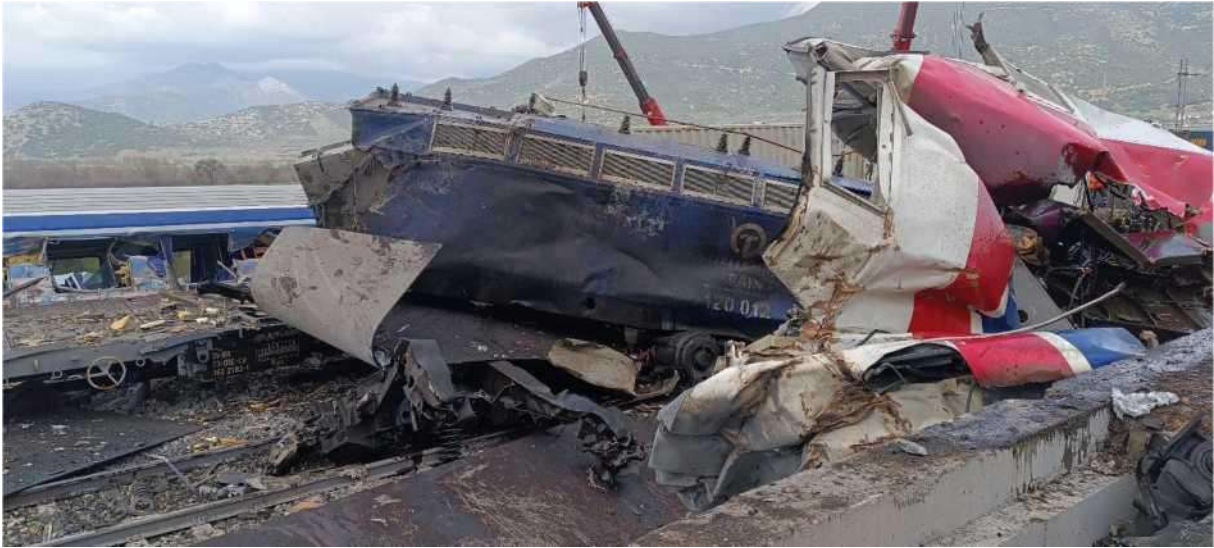
Figure 13. Locomotives 120-022 and 120-012 of the freight train 63503 after the accident. Front view, from the road.

138 By comparing the damage to the steel plates and the Restaurant Car, it can be considered as most likely that the initial impact to the Restaurant Car came not on its front bumper but underneath its “belly”, indicating that the Restaurant Car had a slightly “nose-up” attitude at the moment of the impact, which is consistent with the damage observed on the first and presumably topmost steel plate that was found wedged underneath the blue 120-012 locomotive. Meanwhile, the 1st platform of the freight train sustains very heavy damage from the impact with the Restaurant Car that leaves it bent in half and wedged under the remaining steel plates against the wall, and spread few meters after the collision, in the area before the entrance of the tunnel. (Figure 13, Figure 22).

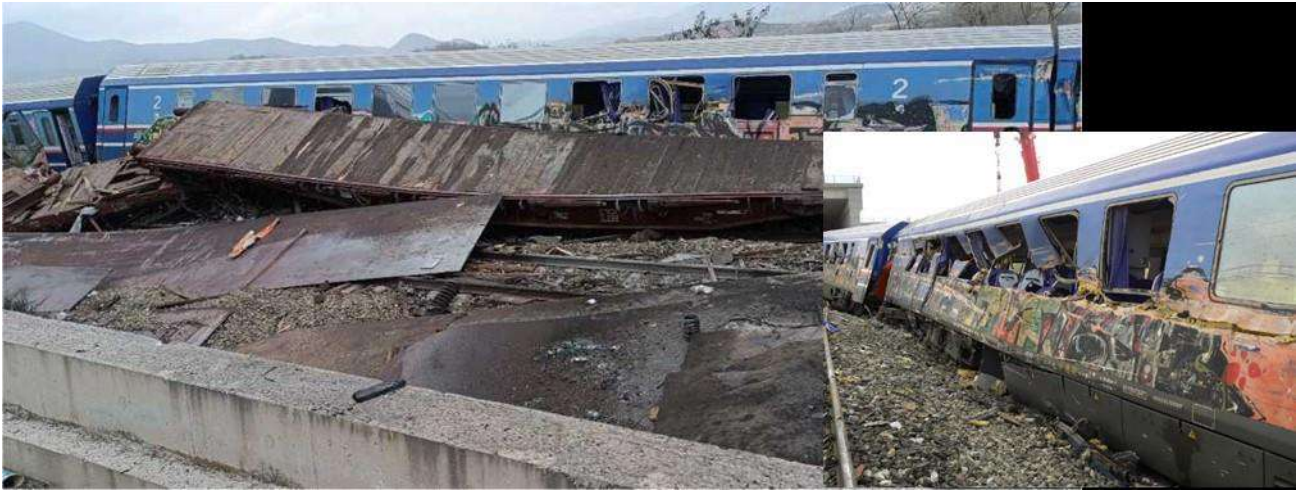
- 143 Meanwhile, the remaining 12 vehicles of freight train 63503 and the remaining 4 vehicles of IC-62 continue their last part of their forward movement, where in addition to braking action there is also side impact between the steel plates and the sides of the 2nd and 3rd platform and the sides of the B3, B4 and B5 coaches of the passenger train (Figure 25).

*Figure 25. Linear impact of steel plates on the side of the coach B4.*

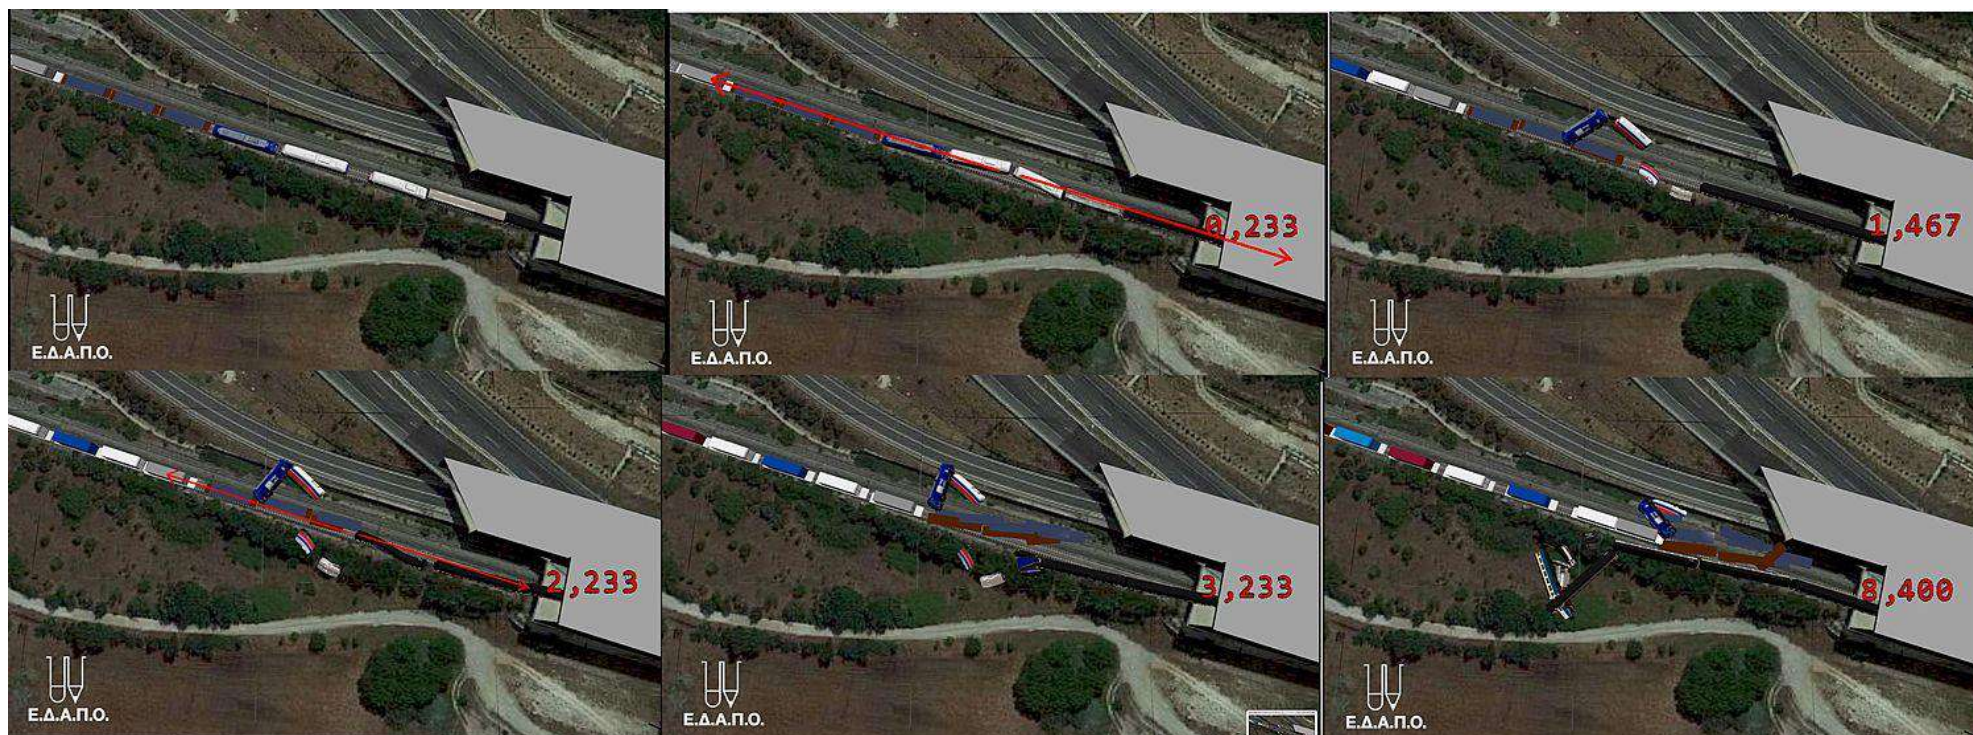
144 Finally, the fourth wagon of the freight train carrying a shipping container, hits the second freight locomotive 120-012 and then comes to a standstill. On the next page (Figure 26), a set of pictures extracted from an animated sequence proposes an overall view of the collisions with their timestamps: image 2 showing the 1st impact, image 4 the 2nd impact and images 5 and 6 the movement till standstill.

Figure 26. Overall view of the simulated accident mechanism with the timestamps: image 2 showing the 1<sup>st</sup> impact, image 4 the 2<sup>nd</sup> impact and images 5 and 6 the movement till standstill.

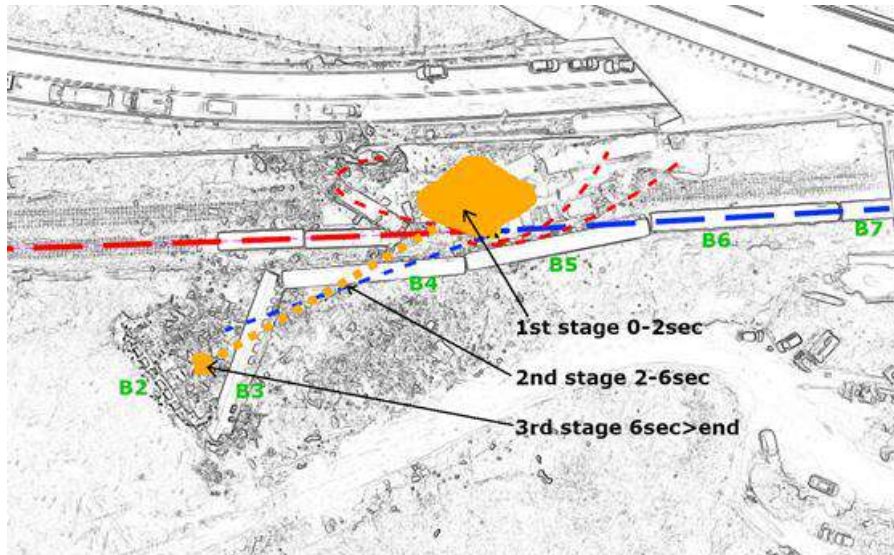
- 147 At the same time, the catenary lines themselves (both lines, one for each direction of travel) have been ripped off due to the collision, but the power was already cut within 0.2-0.3 seconds of the short circuit. Approximately 0.3 seconds after the end of the arc flashes, a fireball starts forming from the ground level and very rapidly expands upwards to a size of approximately 42 meters in diameter, which burns for approximately 2 seconds.
- 148 At approximately 2 seconds after the initial ignition, a second stage starts, when a new fire plume can be observed, moving northbound, away from the 1<sup>st</sup> stage fireball. This new fire plume is feeding the original fireball until it grows to almost double the size (80 meters) at approximately 4 seconds after ignition (Figure 28, Figure 29, Figure 30).

Figure 30. Clarification of the sequence with its timing.

- 439 As described before (3.9.3), observing the course of the fire gives rise to making a distinction between 3 different stages (Figure 30, page 47):

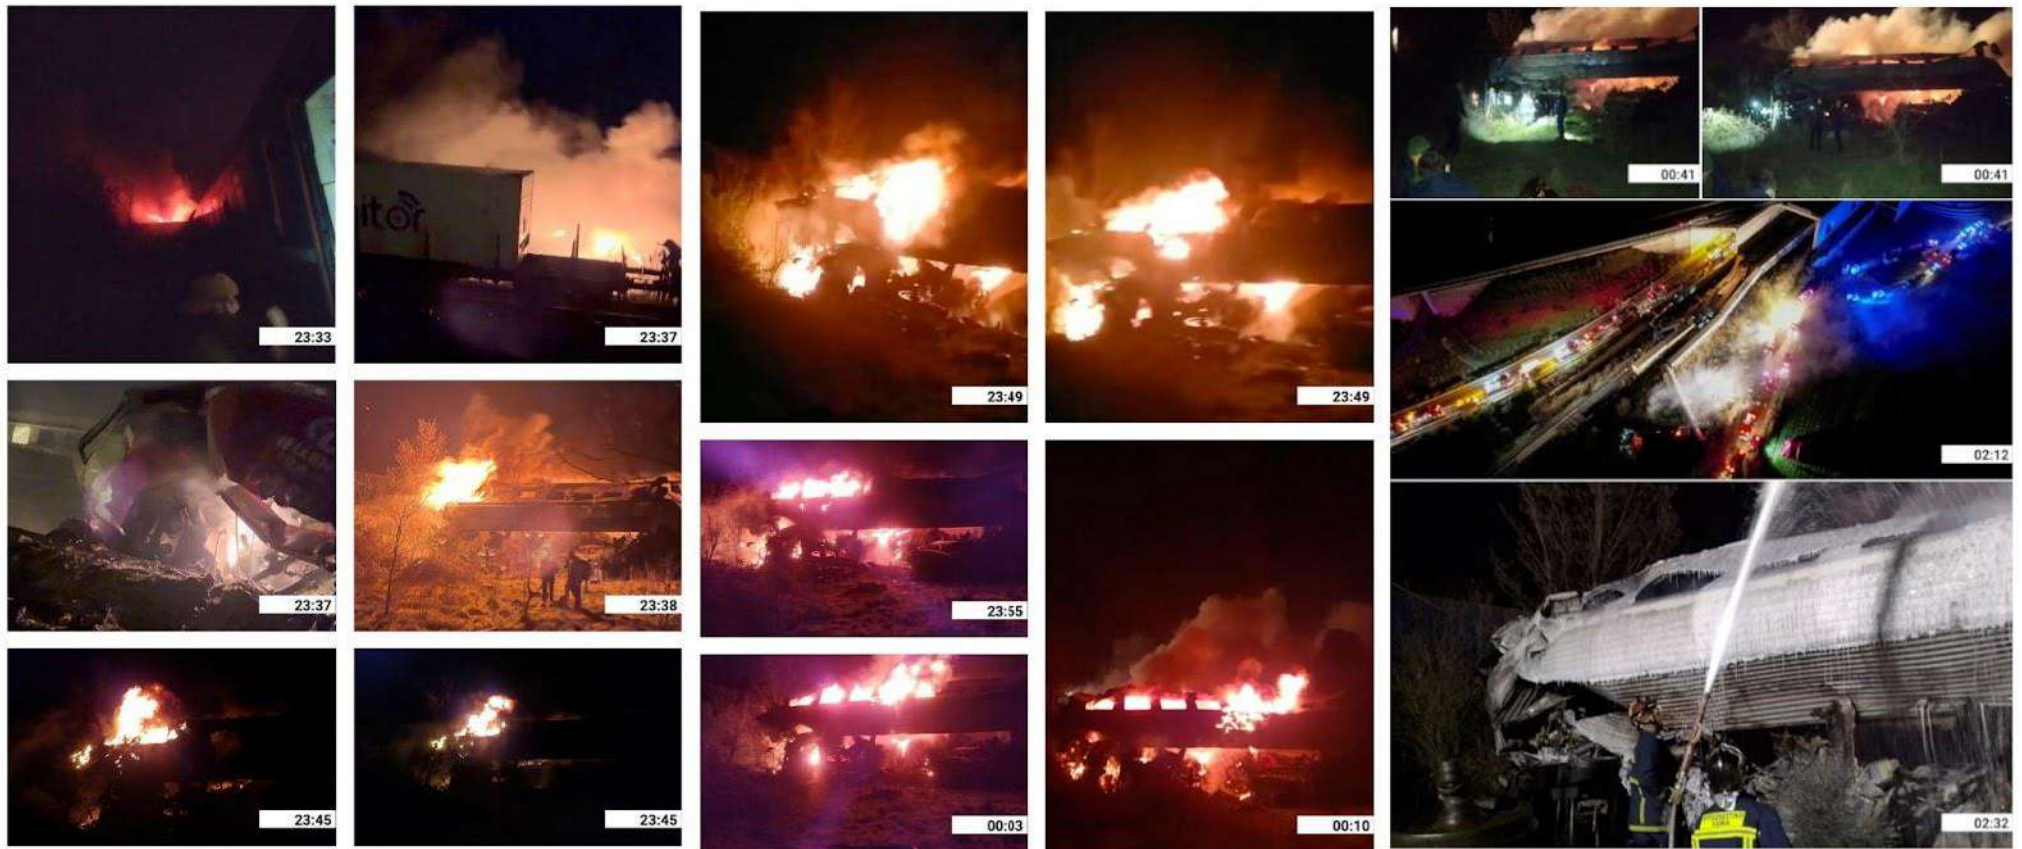
- 157 From the work of the EDAPO team of investigators, more details and a rebuild of the timeline of the fires are available, with timestamp on photos (Figure 35, next page). This timeline describes the development and decay of the fire (source: EDAPO).

Figure 35. Photos of the fires development and their timestamp (source: EDAPO).

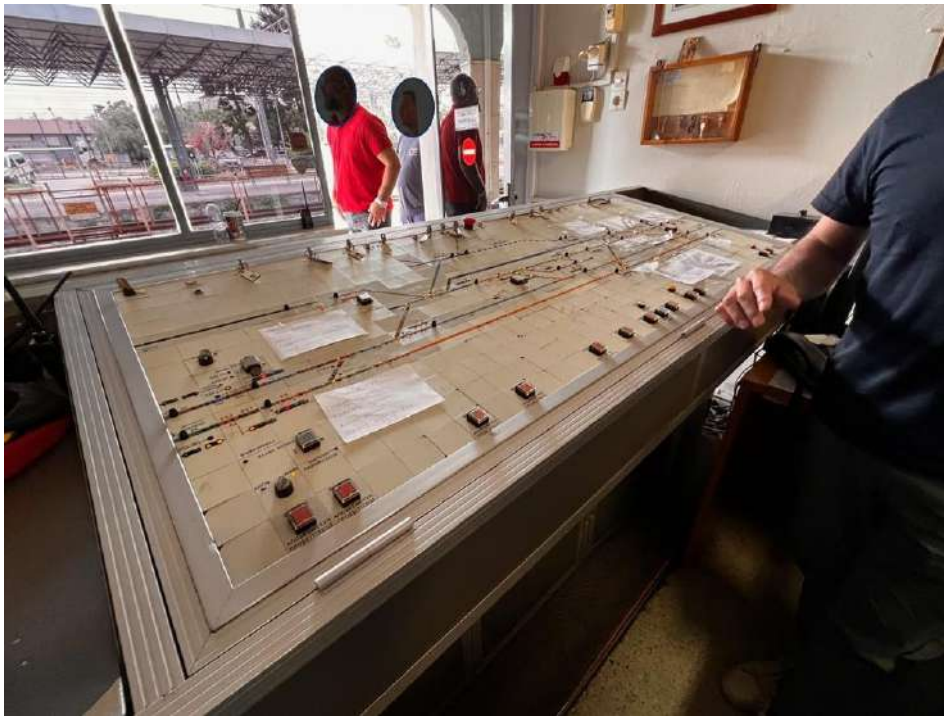
Figure 37. The control panel at Larissa Station

- 189 As it can be observed on the global photo of the control panel (Figure 37), it is a large area with many information and commands that cannot be considered at a glance. To pass from one mode to the other (manual mode to or from automated mode), the station masters must turn a numbered key (the number refers the number of the switch) on the top of the control panel (Figure 46), separately for each switch. The area where to read the switches numbers is small and partially hidden by the plastic and metal key rings (this point is further analysed in the chapter 4.2.2). In the actual practice of using these keys, as it has been explained and shown on site, at least two ways of manipulating them co-exist, one of them being indicative of lack of trust in the system and/or lack of experience (4.2.1.3).

- 243 The indications on the position of switched 118 are small indications, on two distinct positions, on a larger Control Panel (the information of the Figure 47 among the ones from the whole Figure 37).

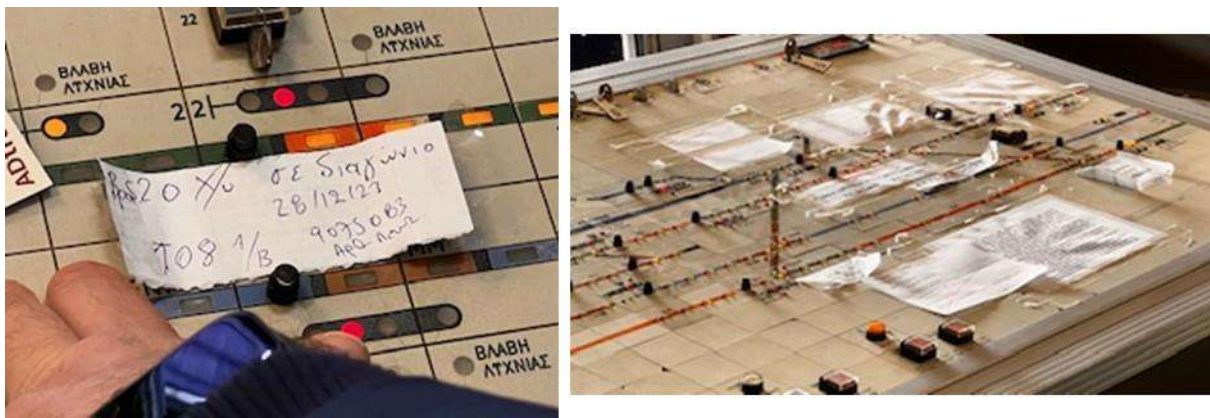
191 The Larissa control panel in the station masters' traffic control room, as well as others in actual operation (Figure 40), is supplemented by pieces of paper “taped” or just “laid” on the inclined panel. Their operational function is to remind the station masters of important local information on operational restrictions or degradations, some for a few hours, others for months (and even longer).

Figure 40. Useful pieces of information.

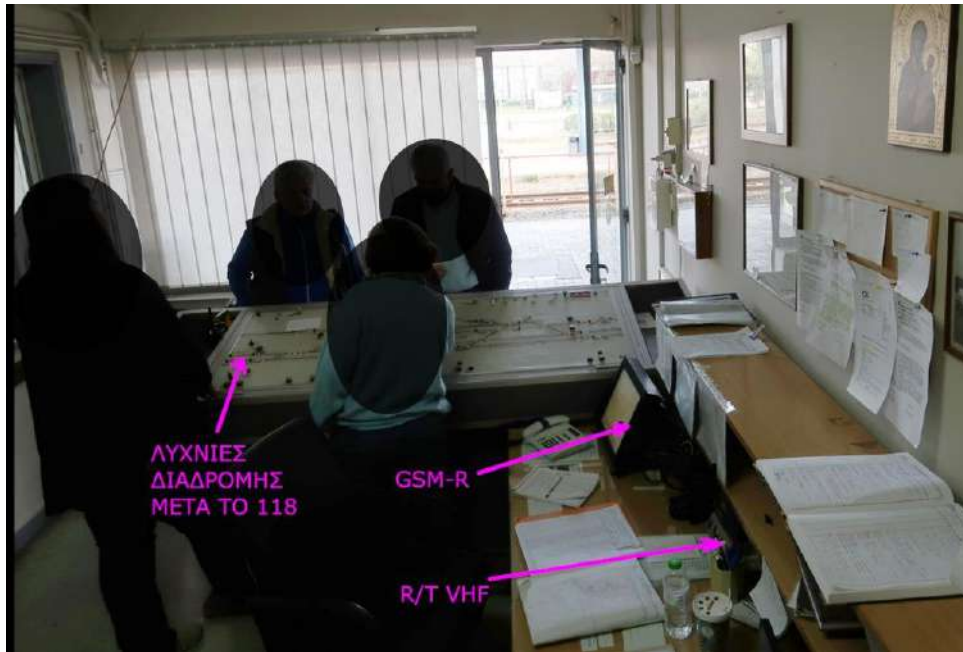
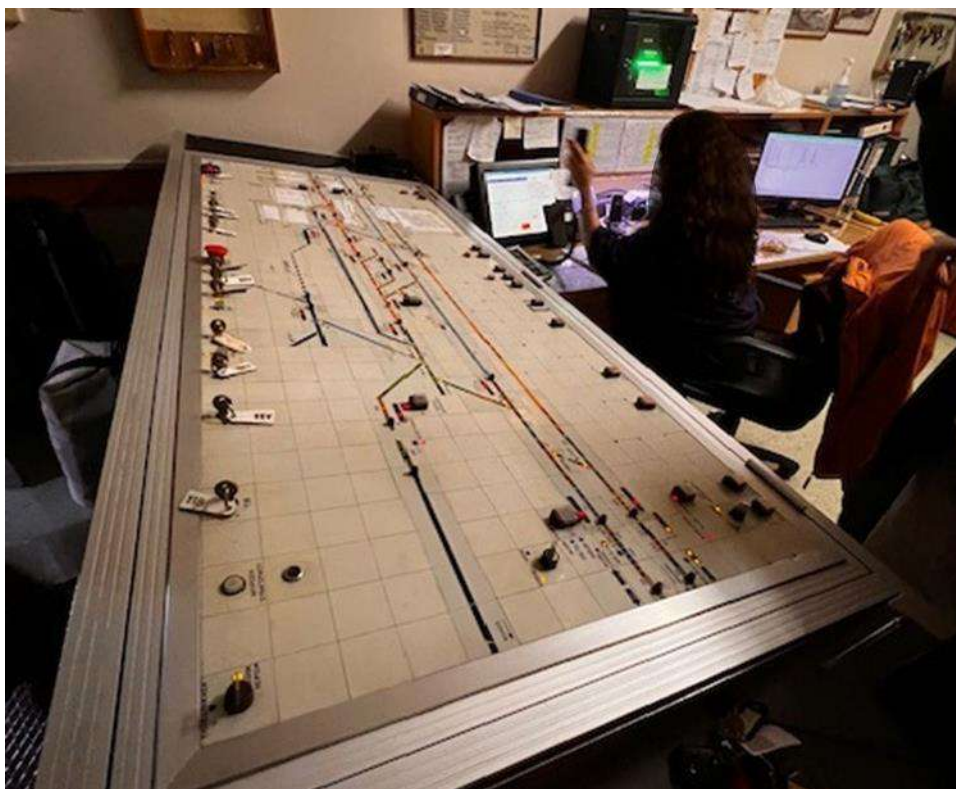
192 Taken together with another source of influence, namely the numerous communications (as analysed in point 4.2.1.8), in the period of time just before and while the control panel was showing the passage of train IC-62 (240), it should be noted that this panel and the communications area are organised and physically positioned in a way that makes it very difficult to perform both tasks at the same moment. In morning and afternoon shifts these tasks are performed by two station masters in order to avoid excessive workload. When you are concentrating on communications, you are turned sideways in relation to the control panel and the LEDs that are lit in this case are behind you (Figure 41. Positions of station masters when facing the control panel (above) and when

193 ). This directly, logically and naturally explains how Larissa's station master did not 'see' or 'look', and therefore did not 'detect' the train's passage towards the descending track (4.2.2). During the investigation, 2 other situations were identified by the investigation team: one in which the station masters had adapted it and added a desk just in front of the control panel (Figure 42), and the other one, in Athens, when a Station Manager reported this as an issue and their manager made the situation more adapted.

Figure 41. Positions of station masters when facing the control panel (above) and when communicating (below) in Larissa station.

- 245 Furthermore, the way the communication means (VHF console, GSM-R and telephone) are positioned on the right of the control panel and at a lower level (Figure 41). This means that, when occupied with whatever communication and logically directed towards the used means of communication, the indications related to the position of switches 118 and the departure of train IC-62 were situated behind the left shoulder of the station master in the left bottom corner of the control panel and so in practice invisible (192).

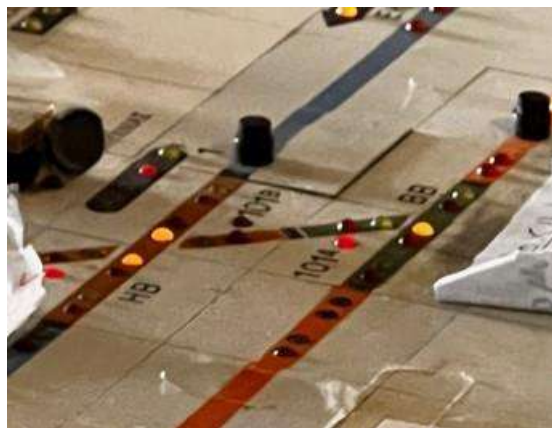
Figure 43. Switches 101A/B

- 214 Due to a problem with the overhead line that occurred earlier that day, traffic between the station of Paleofarsalo and Larissa was operated on a single line (92). This requires additional attention as well as specific communication between both station masters. Furthermore, this also requires an additional action for the trains that enter Larissa from Paleofarsalo from the descending track because the switch-combination 101 had to be turned into the bypass position to allow them onto track 2 in Larissa station (Figure 43).

- 215 Due to technical problems the switch 101A could not be operated remotely (94, Figure 43), via the control panel. To be able to maneuver the switch in the desired position, the station master has to instruct the local switch operator who in turn has to walk towards the switches and fix them in the requested position with a physical intervention. The station master in Larissa instructed the local switch operator at 22:46 to position switches 101 in a bypass position, directly after being informed by the station master of Paleofarsalo that train IC-62 had left for Larissa. At 22:57, the switch operator informed that the activity was performed.

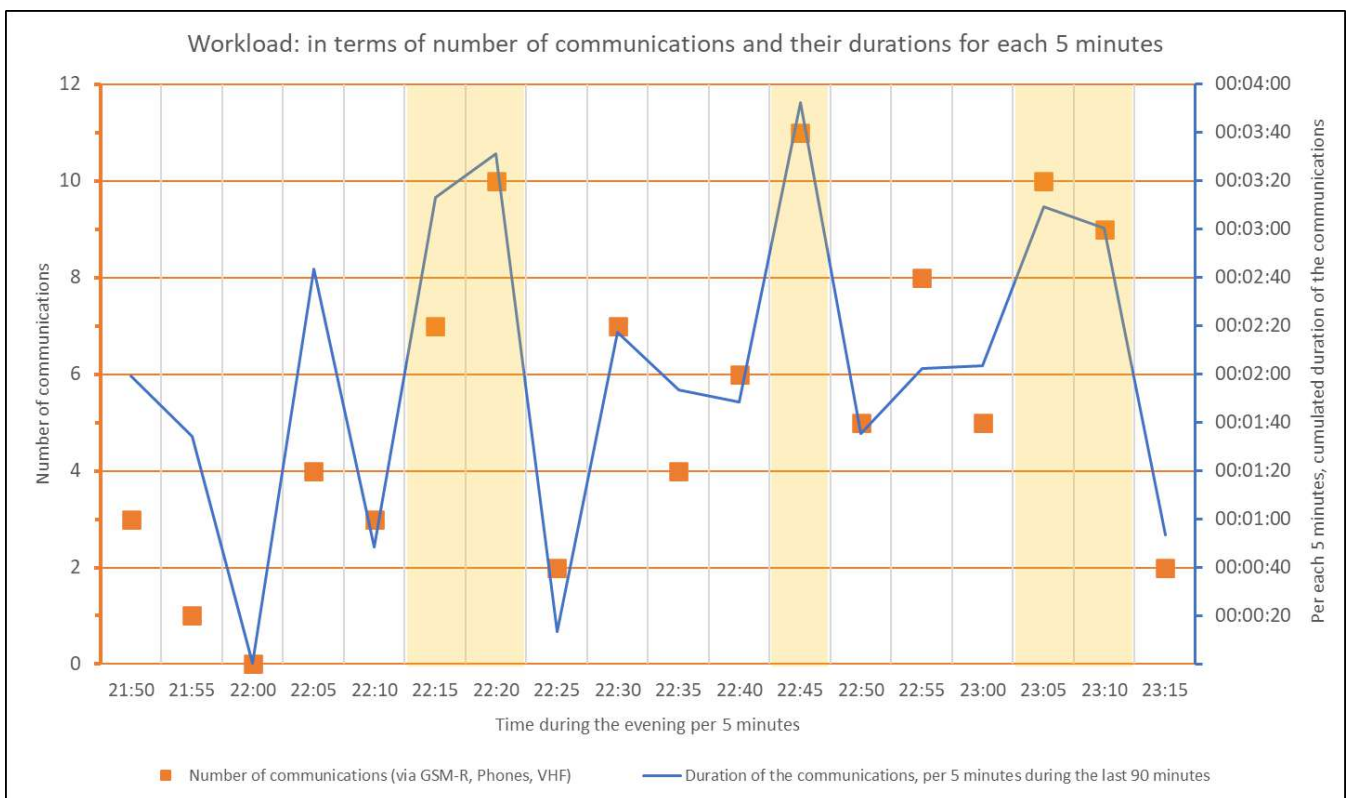
Figure 44. Factual analysis of the communication workload as a risk to be taken into account during HOF integration.

- 220 Analysis of only the communications, not even taking into account other tasks, indicate three peak periods (Figure 44) that appear to correspond with the consecutive mistakes made by the station master: setting the routes for respectively the train 2597 and IC-62 and not detecting the mistake with switch 118. This indicates that periods of too heavy workload, in particular for less experiences operators, can be a direct cause for errors, mistakes and routine violation, because there is “no-time-to-think” or one is “captured-by-the-flow-of-issues-to-contain”. This type of workload analysis, with results beyond human capabilities, shows the importance of integration human and organisational factors in risk management practices (4.2.80).

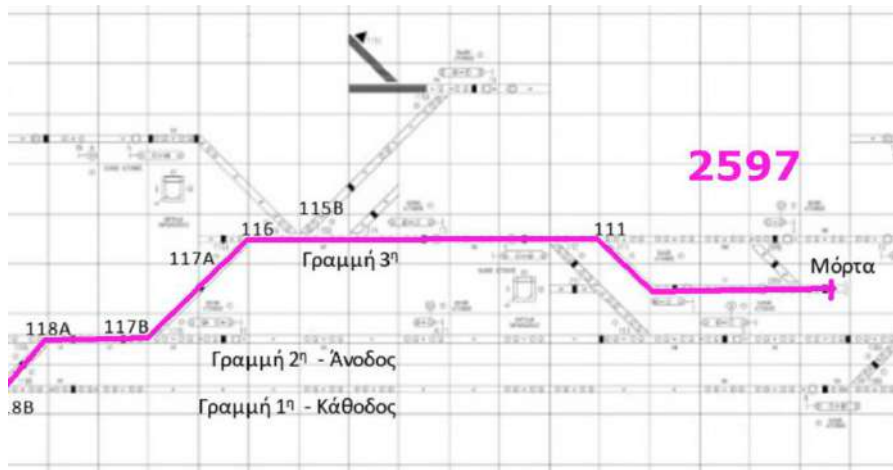
Figure 45. The route for the entry of train 2597.

- 222 Approximately around 22:35, after having received a call from the train driver of train 2597 that he was approaching the station, the station master of Larissa manually set the route with the intention for train 2597 to enter Larissa station from the north and be guided to the dead-end track between tracks 2 and 3.
- 223 This would require the setting of switches 118A/B, 117 A/B, 116, 115B and 111 to be turned in the adequate position (Figure 45). Note that this is also the action that directed switches 118 in the bypass position. Before that, these switches were turned in the straightforward position at 22:12 for the entry of train IC-63. From the recorded actions on the control panel, it can be seen that this was the last time before the departure of train IC-62 that the switches 118 were manipulated through automatic route setting.

When manually setting the route for the entry of train 2597, the station master of Larissa forgot to turn the switches 116 and 115B in the correct position. On other occasions these switches would have been in the right position after the entry and acceptance of train 2575 from Volos on track 3. Earlier in the evening, on the 28/02 this train 2575 was positioned on track 6 at 22:10 by the station master of the afternoon shift because track 3 was occupied with train 2594 that had been brought back to the station at 21:30 after traction problems arose on its way to Neoi Poroi (93).

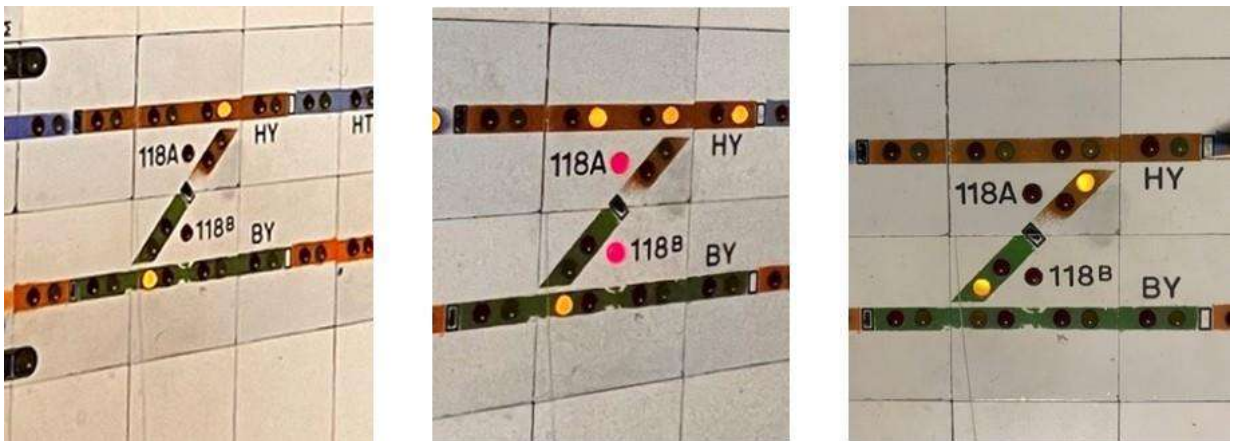
Figure 47. Detail of the switches 118 on the Larissa Control Panel (main-moving-bypass).

237 Switches are indicated on the Control Panel by the intersection of the lines showing the railway lines. Each switch is marked with a number and a letter if two switches have the same number. There are two yellow lights that indicate the position of the switch position in "main" or "bypass"(Figure 47). By setting the route, the lights in the area of the switches light up, as a combination of the light at the entrance of the switch and either the "main" or "bypass" path.

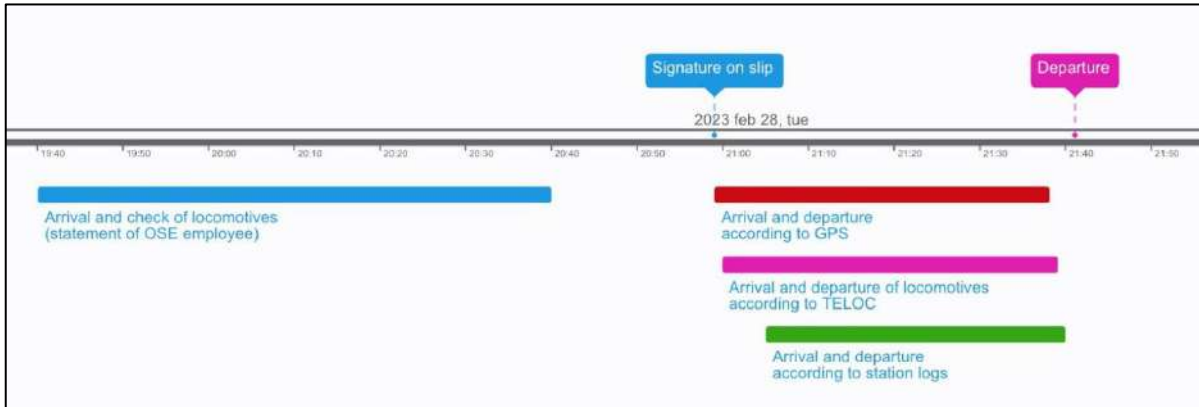
Figure 51. Timeline of the movement of the freight train 63503

284 The same timeline of events is supported by GPS data of the movement of the locomotives as provided by Hellenic Train. A similar timeline is supported also by the logbook of the station master at Thessaloniki Freight Station (locomotives arrive at 21:05, test finished by 21:35 and train leaving at 21:40).

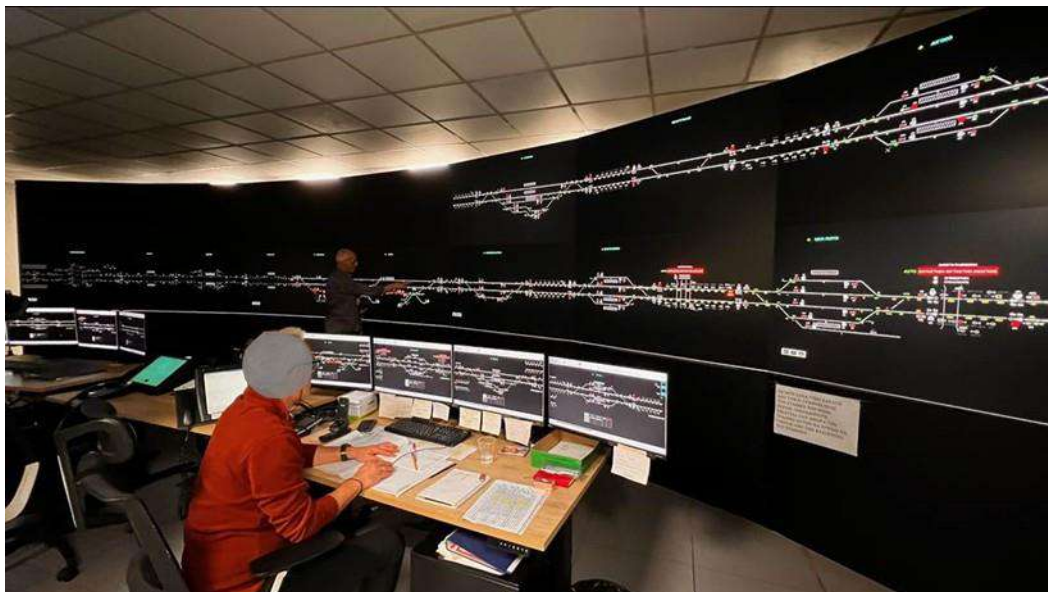
Figure 52. Digitalised traffic control room in Larissa station, with experienced staff, in 2025.

315 Another level of performance monitoring is also possible through the digitalised traffic control rooms (note that such a control room was not in place at the Tempi accident occurred), and this concerns the supervision of traffic in tunnels, and also, as in the example below, traffic management itself. As was observed during on-site visits (Figure 52), on several occasions during the investigation, it is clear that decision made via the control panel in Larissa station a few dozen meters further on (just as it could also be fifty or hundred kilometers) can easily be observed and supervised. However, it is currently not used in that way, and it is not clear if there is any intention to do so in the future. It was observed that there has been an effort to put into operation these traffic control rooms wherever infrastructure (signalling) is available. Their use, however, is still limited by lack of the maintenance of the switches. As a result, still large parts of the Athens-Thessaloniki route are not monitored remotely.

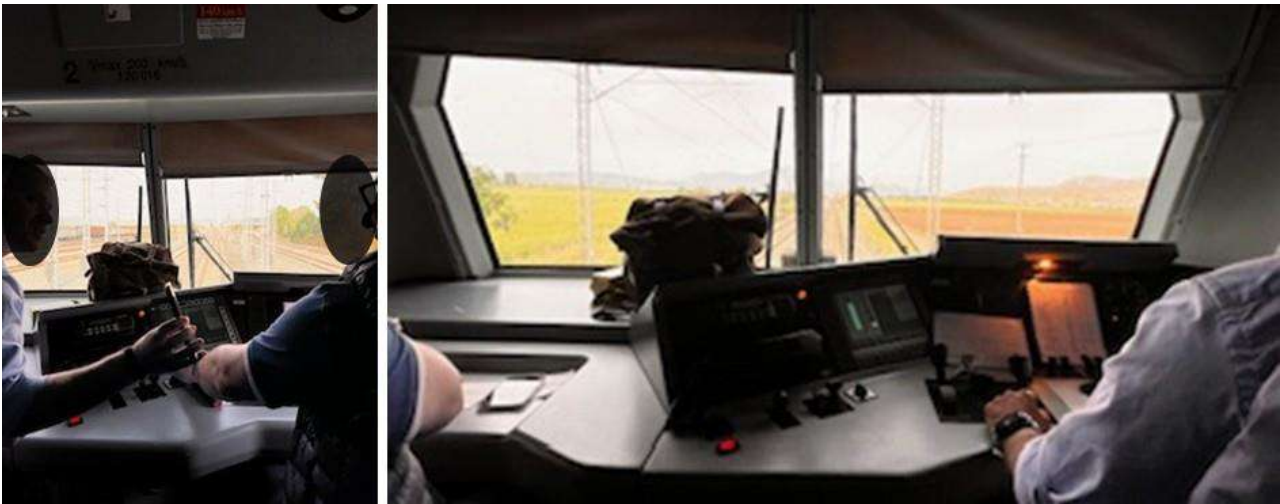
Figure 53. Photos of the train drivers crew, positions and alternance.

349 Another important part of the competence management system is related to non-technical skills, behaviours and attitudes. As previously reported (264, 265), in a context where two train drivers (and sometimes even more) are sharing the driving responsibilities in an alternate way (Figure 53), it is expected they benefit from a crew resources management training, developing their non-technical key competencies (ex. management of stress, of time, of anger, error detection and recovery, etc.). This would also include the capabilities, the willingness, and openness to solve and report any issue related to safety in a context of diverse interpersonal relationships (especially with issues related to obedience, power, and respect issues). This type of peer-review and/or crew resources management is useful when well framed and embedded in an open culture, and in the training of non-technical skills, and eventually contributing to the overall performance and continuous improvement. We could however not identify any structured approach and or guiding directions that would support this.

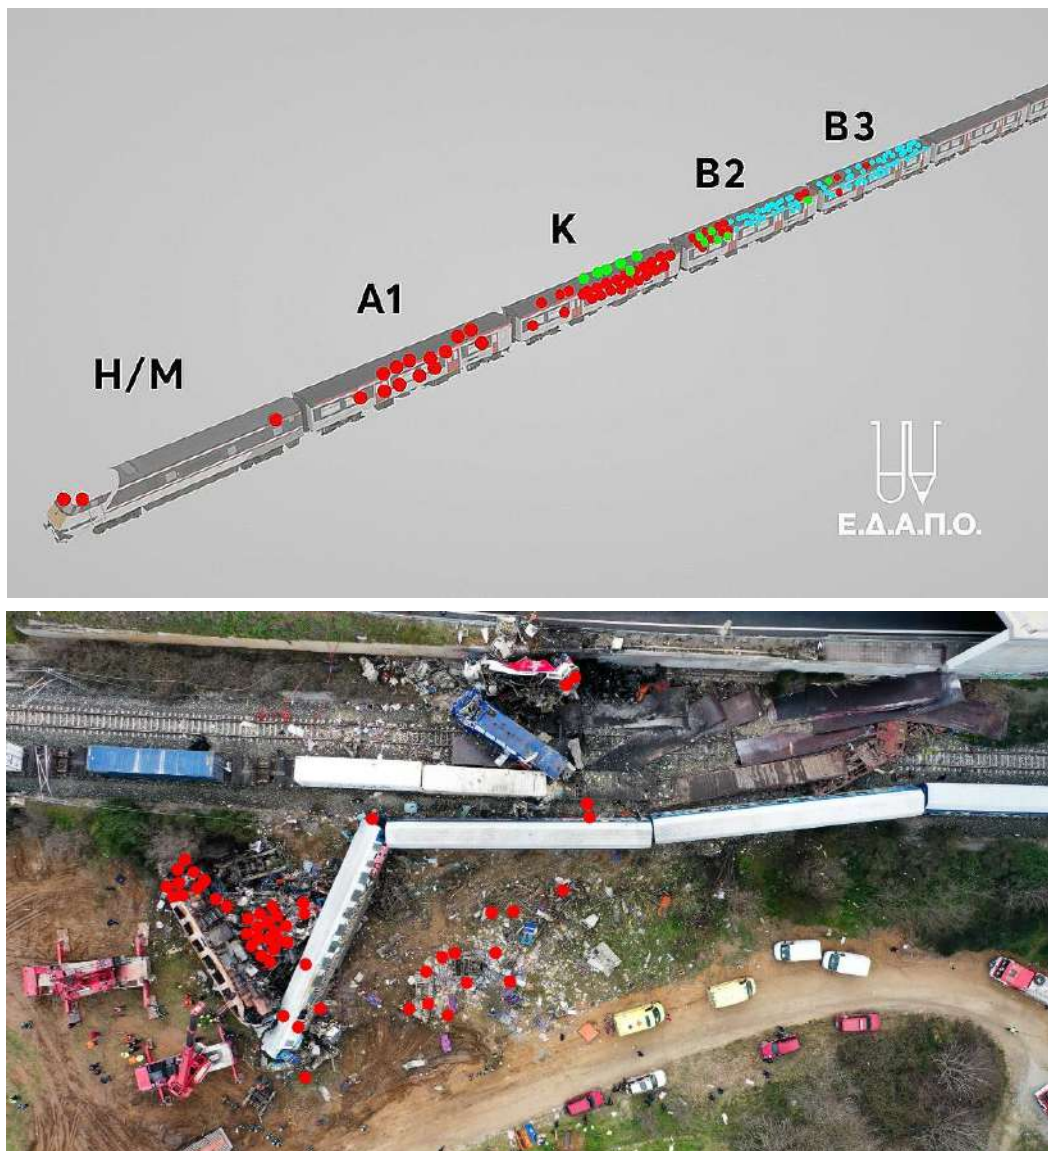
Figure 55. Initial and final estimated positions of fatalities, visualised on the scheme of the impacted part of the IC-62, and on-site.

- 423 The B3 coach of the passenger train was not subjected to heavy deceleration forces and was totally survivable, if not for secondary impacts from the B2 coach hitting its roof and a section of the locomotive hitting against the side of the B3 coach. There were 2 casualties that both suffered severe head and spinal trauma due to impact by heavy debris entering through the side windows. Both casualties were killed instantly without any chance of survival, given the unlucky position they happened to be at (other passengers sitting next to them were practically unharmed). And 5 injured victims were ejected during the crash or jumped from a height to exit the carriage.

- 445 Of the total length of the passenger train IC-62, the only parts that were totally consumed by the fire were the rear part of the Restaurant Car (letter K on the drawing, Figure 55, page 91) and the B2 passenger coach.

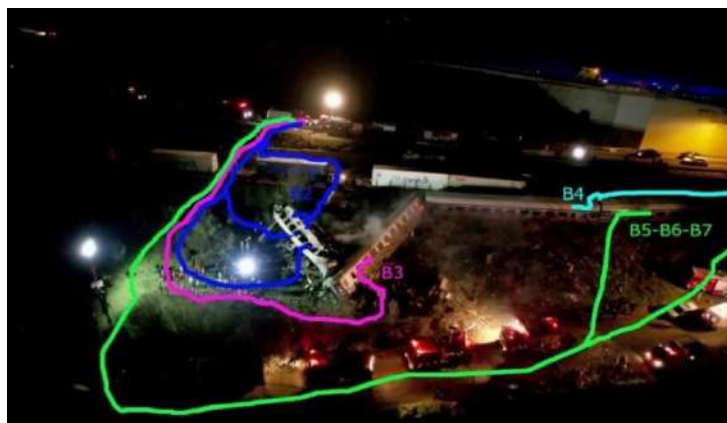
Figure 56. Self-evacuation paths of passengers before emergency services arrived at the scene.

- 428 At least two passengers sustained serious injuries (bone fractures and dislocations) during evacuation: 1 female passenger jumped from the top row of windows of the B2 coach and was injured by falling on debris below (subsequent passengers jumping from the same window avoided this by throwing their luggage to land on top of softer surface) and 1 male passenger who was the first to jump from the B3 coach front left window, sustained serious injuries by falling on debris below (subsequent passengers evacuating from the same window took care to climb down carefully in order to avoid injury). An unknown number of passengers were reportedly lightly injured during evacuation, mostly in a similar way.

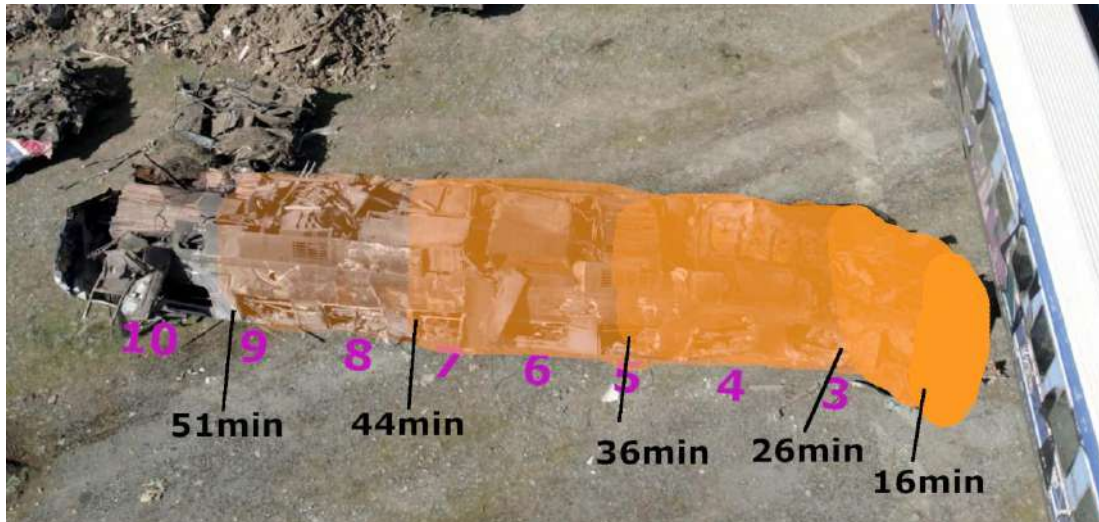
Figure 57. Progression of the fire in the B2 coach (from right to left, in minutes). (Source: EDAPO)

449 This secondary fire of the B2 coach started from the bottom part and in due course (around 23:35) went up to the front part of the B2 coach and consumed the entire length of it, without any active firefighting until the fire reached the end of the wagon and started to threaten the B3 wagon (Figure 57). By 23:38 or after about 16-20 min, the front of the B2 wagon had started to burn with very strong flames. After that stage, this fire did not show any abnormal or unexpected speed and flame strength (Figure 57). The slow speed of this fire is consistent with a fire that feeds on the upholstery, the fittings and the construction materials of the carriage itself, without the obvious presence of any accelerant. Without any firefighting (either active or automatic), the fire took its course and burned every flammable material available. After about 35-40 min, the fire had advanced further along the coach and by 00:00 it had passed midway through the available length. By 00:40, the fire had consumed the entire length of the B2 and had started to self-extinguish, likely having nothing else to burn.

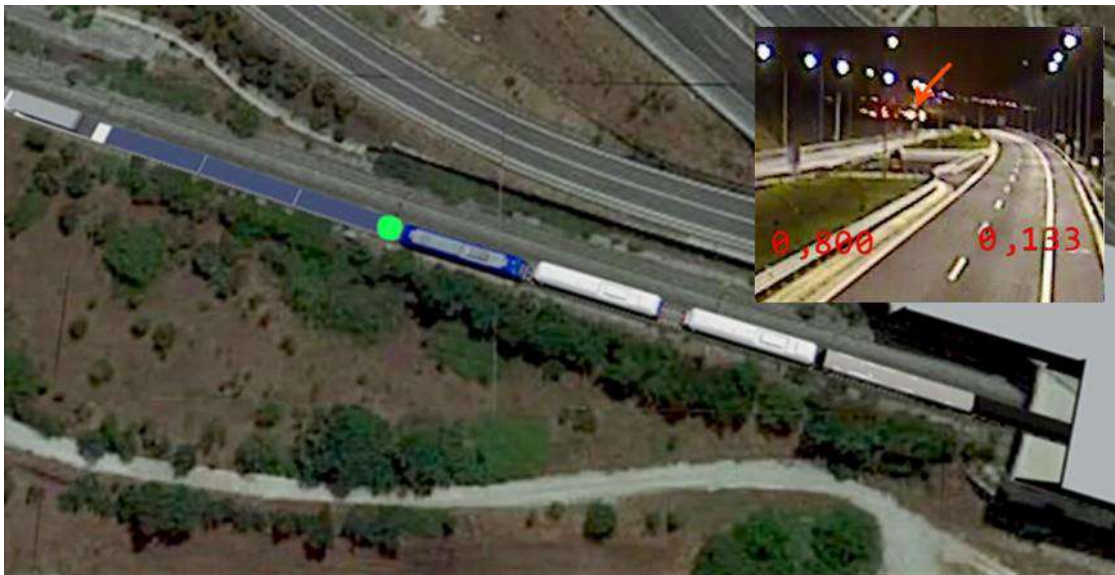
Figure 58. Estimated point of initial ignition.

- 456 The deflagration is ignited approximately 0.3 seconds after observing the electric arc, and it starts at ground level (note the hemispherical shape) with the huge amount of sparks from the emergency brakes locking the wheels of both trains (consistent with victims' testimonies) being the most probable source of ignition.

- 457 A comparison between the viewing angles of the three available cameras with an effort (via triangulation coupled with kinematic analysis of the crash sequence) to locate the exact point of initial ignition shows a probable point of ignition in the area between the 2nd locomotive of the 63603 freight train and the first flatbed carriage of the same train (Figure 58).
