**HARSIA**  
Hellenic Air & Rail  
safety Investigation Authority

Rail Accident Report

Head-on collision between a passenger train and a freight train  
in Tempi, 28 February 2023

RL01-2025, 27 February 2025

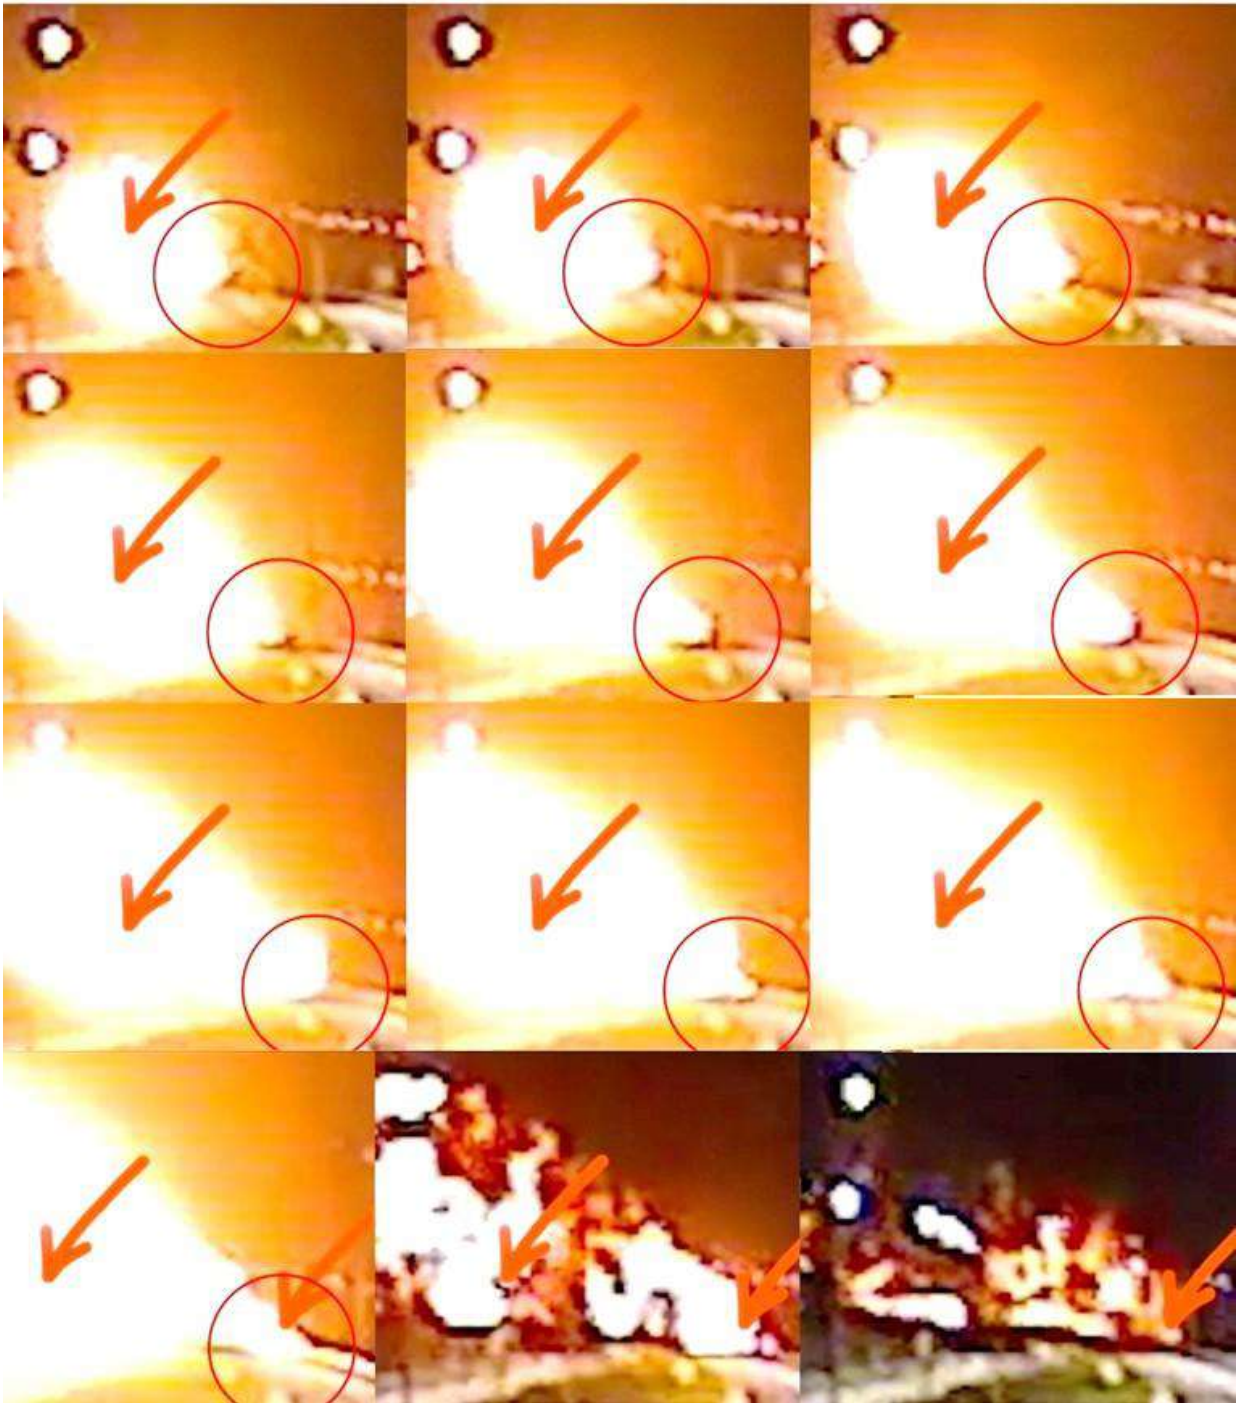
Figure 59. The sequence of the fire from the point of collision to the final stage.

- 458 The following sequence of images (frames from the Aegean Motorway video) starts at 2 seconds after the initial deflagration that started at the place indicated by the red arrow. As can be observed by these video frames, a dark irregular shape is moving in a northbound direction for a duration of approximately 4 seconds, during which time strong flames can be observed coming out. The distance covered was approximately 40 meters so this gives a mean speed of 10m/sec or 36kph for the carriage until it comes to a stop.

- 461 The above frames from the Aegean Motorway video (Figure 59) do not allow to identify the dark irregular shape. To be able to identify this part of the passenger train that was making the fireball move to the north, evidence from the video that has recorded the event from the southern side ("Maliakos-Kleidi" camera), and other available videos collected by passengers a few minutes after the crash was correlated.

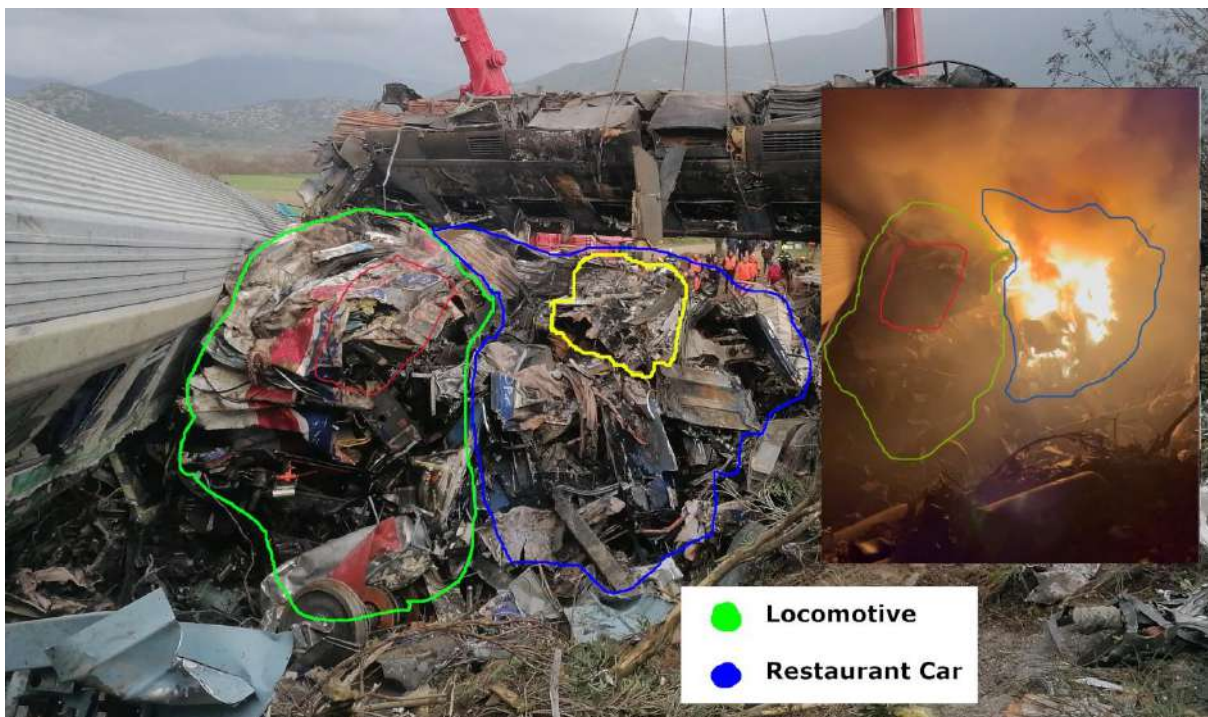
Figure 60. Restaurant burning next to the passenger train locomotive, with the position of the transformer in red.

- 462 The passenger videos show a very strong but very concentrated fire burning fiercely from the bottom of the Restaurant Car (color yellow added) while the remains of the passenger train locomotive (including the transformer filled with silicone oil) can be observed at a very close distance but clearly not on fire. This observation can be verified by the examination of the remains of the trains on the next day (Figure 60, Figure 61), where it is clear that the locomotive (color green added) is mechanically destroyed and, like the transformer (color red added), only has burn marks on one side, while the Restaurant Car (color blue added) is totally consumed by the fire.

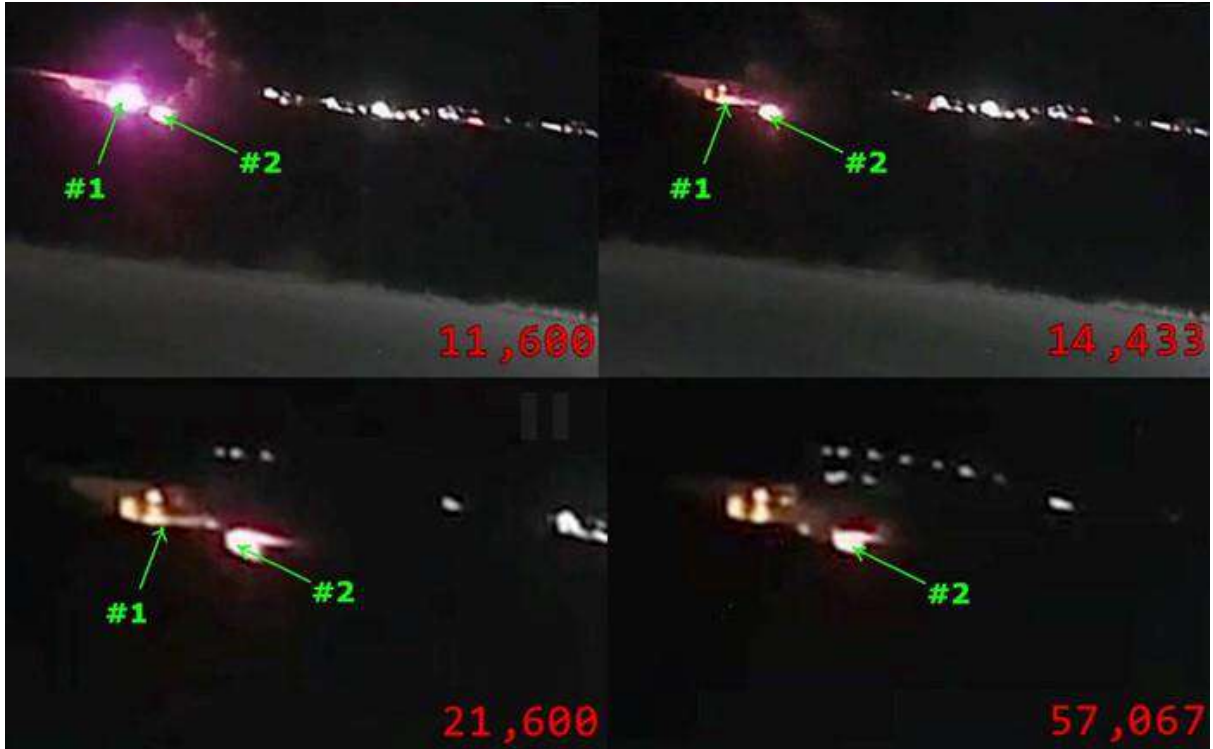
Figure 62. Fire plume moving into pool fire #2, as observed by the "Maliakos-Kleidi" camera.

463 By following this fire backwards in time, it is most likely that the fire that consumed the Restaurant Car is the same fire that has been recorded 4 minutes after the crash, burning from the bottom of the (crashed and bent in an S-shape) Restaurant Car (color yellow added). This is also the same fire that is observed from the "Maliakos-Kleidi" camera (Fig. Y), as an uninterrupted continuous movement from the fire plume (stage 2) to pool fire #2 (stage 3).

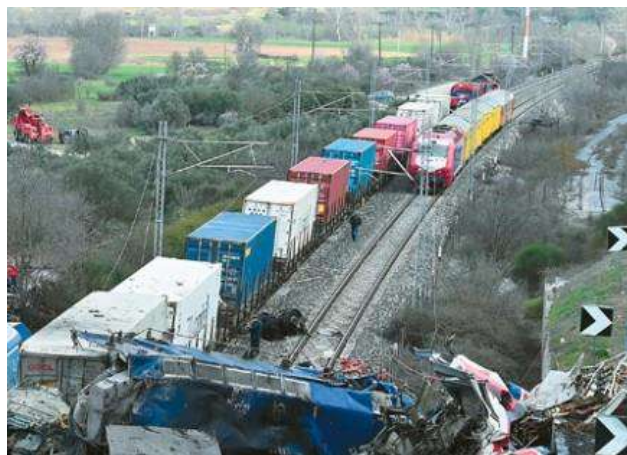
Figure 84. Positions 8)-15) The remaining platforms carrying 8 containers, undamaged and still sealed (or remained empty, of the 2 last ones), not derailed, stopped along the line and were driven away normally.

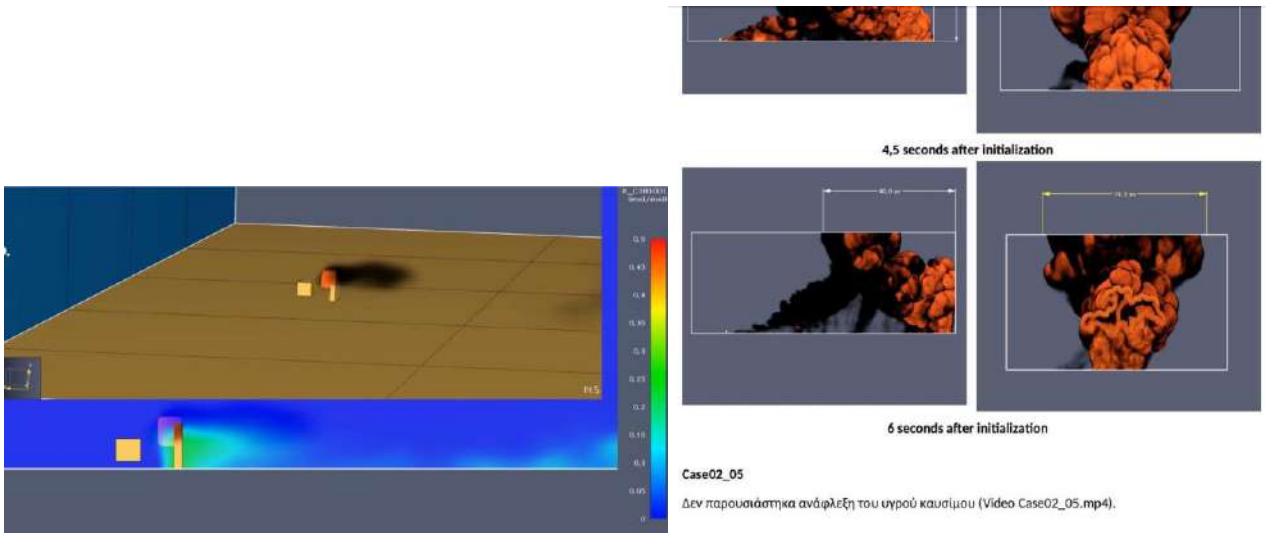
Various tests were run in order to simulate the possibility of silicone oil actually igniting in the presence of a heat source, in the form of an open flame (a pool fire inside a large bucket) or a heated vertical plate. Silicone oil was considered already atomized in small droplets of 500nm (much smaller than the 1000-4000nm as estimated by the RI.SE. report) and the total quantity of fuel was blown in particle form against a heated wall or an open flame. Several simulations were run using different geometries of release and dispersion and different values of AIT (auto-ignition temperature), starting from the realistic value of 450C and going down to 350C as suggested by UGent in order to simulate the possibility of piloted ignition, and even down to 250C which is an unrealistically low value that would be representative of less safe mineral oils.

The results of these tests rule out the possibility of PDMS silicone oils creating such a big fireball and pool fire, as the only possible result is a small localized ignition that will not propagate through the rest of the material, even if the total quantity of silicone oil is unrealistically atomized and dispersed all over the area.
